Accessibility

Audit Report

BusConnects Radial Core Bus Corridors Infrastructure Upgrade Programme – Project B

Liffey Valley to City Centre Core Bus Corridor -Accessibility Audit Report

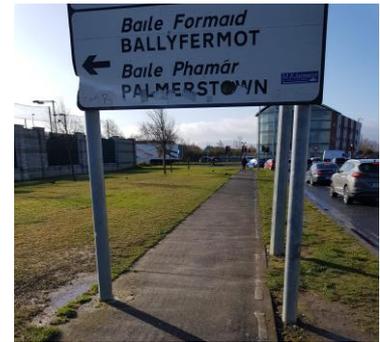
Figure 2.4: Road sign too low

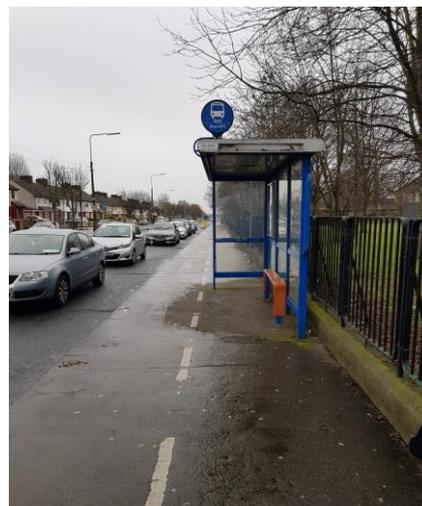
Figure 3.4: Inappropriate street furniture

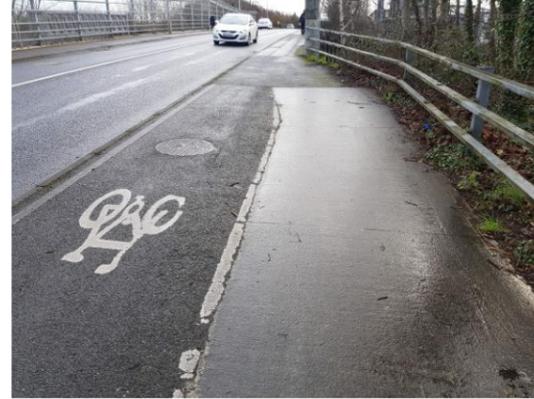
<p>392 - No tactile paving at crossing</p>	<p>394 - No level difference between footpath and cycle lane</p>	<p>396 - Unsuitable access for users with disabilities</p>	<p>397 - Uneven paving / footway</p>
<p>This is located on Coldcut Road just west of the M50. It is considered high severity as a lack of tactile paving makes visually impaired pedestrians unaware of the presence of the crossing.</p>	<p>This is located on Coldcut Road just west of the M50. It is considered high severity due to the risk of collision between pedestrians and cyclists.</p>	<p>This is located on Coldcut Road just west of the M50. It is considered high severity due to the risk of collision between pedestrians and cyclists.</p>	<p>This is located on Coldcut Road on the bridge above the M50. It is considered high severity due to the presence of trip hazards close to the kerb which could result in a fall into traffic. The area also has high noise levels which could make it more difficult for pedestrians to hear hazards.</p>

<p>707288,734233</p>	<p>707320,734235</p>	<p>707411,734225</p>	<p>707444,734222</p>
<p>Solution: Provide required tactile paving.</p>	<p>Solution: Create delineation between the footpath and cycle path.</p>	<p>Solution: Provide tactile paving to indicate the change from shared path to seperated cycle path and footpath.</p>	<p>Solution: Implement more suitable paving which is even.</p>
<p>398 - Unsuitable access for users with disabilities</p>	<p>402 - No tactile paving at crossing</p>	<p>411 - Unsuitable access for users with disabilities</p>	<p>412 - No level difference between footpath and cycle lane</p>
<p>This is located on Coldcut Road just east of the M50. It is considered high severity due to the risk of collision between pedestrians and cyclists.</p>	<p>This is located on Coldcut Road just east of the M50. It is considered high severity as a lack of tactile paving makes visually impaired pedestrians unaware of the presence of the crossing.</p>	<p>This is located on Coldcut Road just east of the M50. It is considered high severity due to the risk of collision between pedestrians and cyclists.</p>	<p>This is located on Coldcut Road just east of the M50. It is considered high severity due to the risk of collision between pedestrians and cyclists.</p>

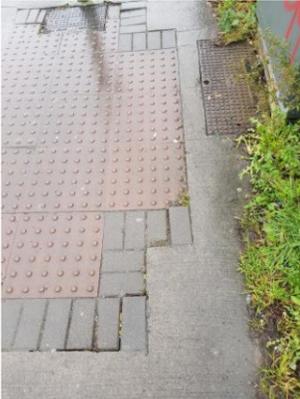
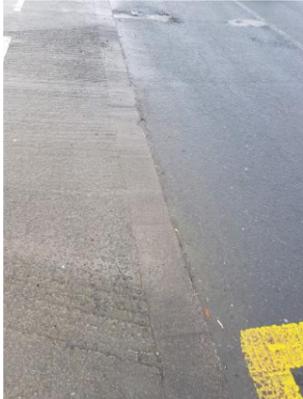
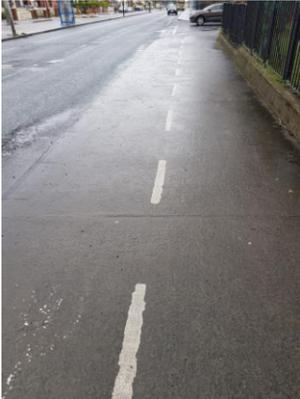
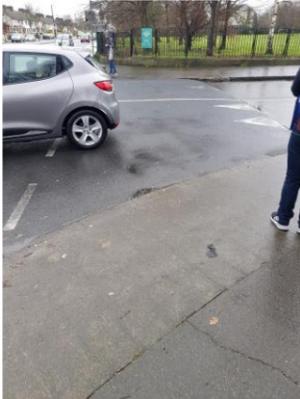
427 - Uneven paving / footway	440 - Inappropriately constructed vehicle crossover point	441 - No level difference between footpath and cycle lane	442 - No tactile paving at crossing (both sides of the crossing)
<p>This is located on Ballyfermot Road outside Cherry Orchard Hospital. It is considered high severity due to the presence of a trip hazard which could result in a fall into traffic.</p>	<p>This is located on Ballyfermot Road east of Cherry Orchard Hospital. It is considered high severity due to the risk of visually impaired pedestrians not being aware of the presence of a kerb and veering into the carriageway.</p>	<p>This is located on Ballyfermot Road east of Cherry Orchard Hospital. It is considered high severity due to the risk of collision between pedestrians and cyclists.</p>	<p>This is located on Ballyfermot Road east of Cherry Orchard Hospital. It is considered high severity as a lack of tactile paving makes visually impaired pedestrians unaware of the presence of the crossing.</p>

<p>708104,733905</p>	<p>708585,733821</p>	<p>708620,733818</p>	<p>708648,733815</p>
<p>Solution: Implement more suitable paving which is even.</p>	<p>Solution: Raise the driveway to meet the required standard height.</p>	<p>Solution: Create delineation between the footpath and cycle path.</p>	<p>Solution: Provide required tactile paving.</p>
443 - Inappropriate street furniture	444 - Inappropriately constructed vehicle crossover point	446 - No crossing facilities provided (both sides of the crossing)	447 - No crossing facilities provided
<p>This is located on Ballyfermot Road east of Cherry Orchard Hospital. It is considered high severity due to the risk of collision between pedestrians and cyclists.</p>	<p>This is located on Ballyfermot Road east of Cherry Orchard Hospital. It is considered high severity due to the risk of visually impaired pedestrians not being aware of the presence of a kerb and veering into the carriageway.</p>	<p>This is located on Ballyfermot Road east of Cherry Orchard Hospital. It is considered high severity as there are no alternatives to crossing at this point and it makes crossing inaccessible.</p>	<p>This is located on Ballyfermot Road east of Cherry Orchard Hospital. It is considered high severity as there are no alternatives to crossing at this point and it makes crossing inaccessible.</p>

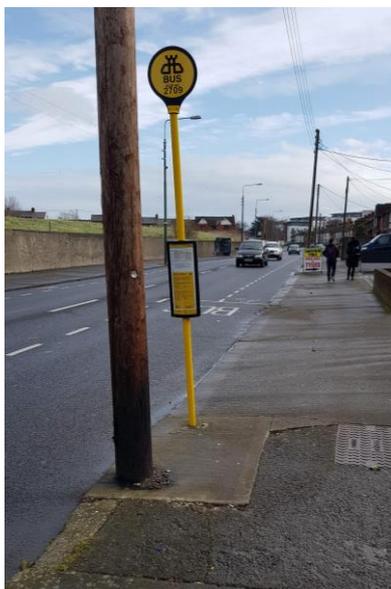
There are 16 bus stops along this section of the route which are not identified in braille. Two of these bus stops do not have a raised kerb sufficient for access to the bus, one of these is shown in Figure 4.4.

Figure 4.4: No raised kerb for length of bus stop

There were two instances of the kerb at the bus stop not being at the correct height for the length of the bus stop. It is recommended that the kerb be 250mm high for the length of the bus stop. For new bus stops, it is suggested that kassel kerbs are used.

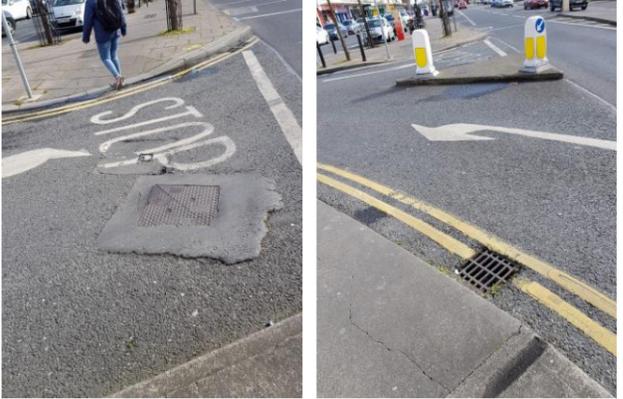
<p>469 - Inappropriately constructed vehicle crossover point</p>	<p>473 - Crossings not aligned</p>	<p>474 - No tactile paving at crossing</p>	<p>743 - No crossing facilities provided</p>
<p>This is located on Ballyfermot Road. It is considered high severity due to the risk of visually impaired pedestrians not being aware of the presence of a kerb and veering into the carriageway.</p>	<p>This is located on Ballyfermot Road. It is considered high severity due to the risk of visually impaired pedestrians walking into the carriageway while trying to use the crossing.</p>	<p>This is located on Ballyfermot Road. It is considered high severity as a lack of tactile paving makes visually impaired pedestrians unaware of the presence of the crossing.</p>	<p>This is located on Ballyfermot Road. It is considered high severity as there are no alternatives to crossing at this point and it makes crossing inaccessible.</p>

<p>709494,733716</p>	<p>709615, 733711</p>	<p>709613, 733708</p>	<p>709501, 733731</p>
<p>Solution: Raise the driveway to meet the required standard height.</p>	<p>Solution: Reposition dropped kerb to align crossing.</p>	<p>Solution: Provide required tactile paving.</p>	<p>Solution: Provide crossing facilities.</p>
<p>486 - No tactile paving at crossing</p>	<p>488 - No tactile paving at crossing</p>	<p>503 - No tactile paving at crossing</p>	<p>508 - Crossings not aligned</p>
<p>This is located on the Ballyfermot Road / Kylemore Road roundabout. It is considered high severity as a lack of tactile paving makes visually impaired pedestrians unaware of the presence of the crossing.</p>	<p>This is located on the Ballyfermot Road / Kylemore Road roundabout. It is considered high severity as a lack of tactile paving makes visually impaired pedestrians unaware of the presence of the crossing.</p>	<p>This is located on Ballyfermot Road. It is considered high severity as a lack of tactile paving makes visually impaired pedestrians unaware of the presence of the crossing.</p>	<p>This is located on Ballyfermot Road. It is considered high severity due to the risk of visually impaired pedestrians walking into the carriageway while trying to use the crossing.</p>

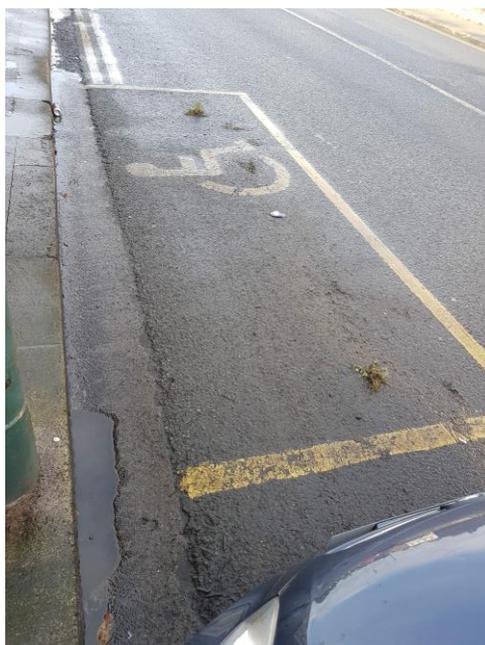
Of the five parking issues identified, there were three instances of accessible parking bays with no dropped kerb provided, Figure 5.4, and two instances of vehicles parked in the footpath.

Figure 5.4: Accessible parking bay with no ramp

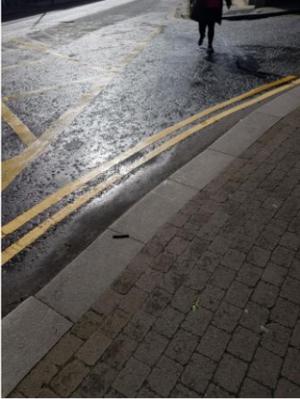
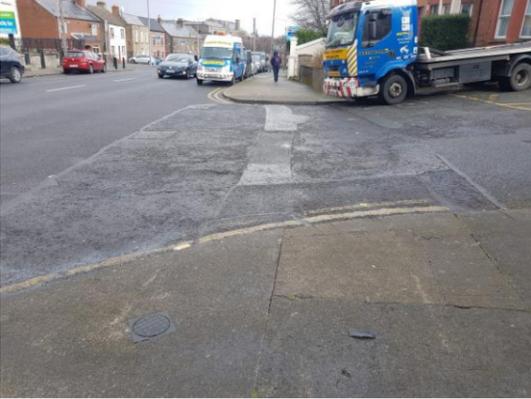
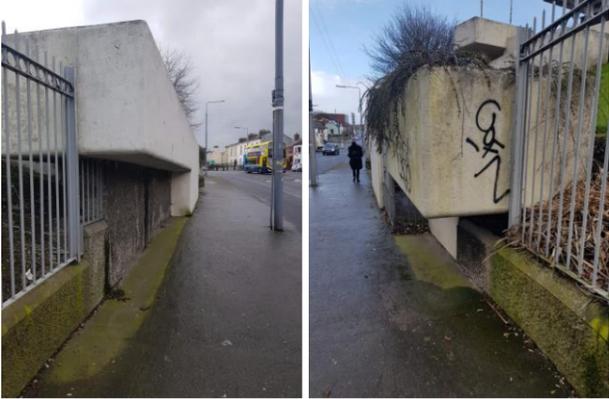
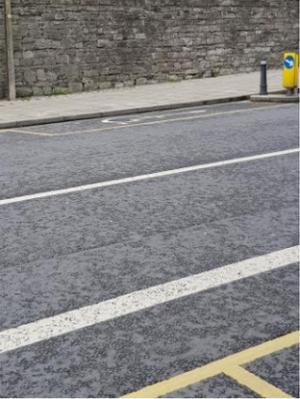
551 - Crossings not aligned	571 - No crossing facilities provided	572 - Unsuitable access for users with disabilities	849 - No dropped kerbs provided at accessible parking bay
<p>This is located on Grattan Crescent. It is considered high severity due to the risk of visually impaired pedestrians walking into the carriageway while trying to use the crossing.</p>	<p>This is located on Emmet Road. It is considered high severity as there are no alternatives to crossing at this point and it makes crossing inaccessible.</p>	<p>This is located on Emmet Road outside Inchicore College of Further Education. It is considered high severity as there is an overhanging building which poses a strike hazard.</p>	<p>This is located on Grattan Crescent. It is considered high severity as it makes the parking bay inaccessible to people using wheelchairs or walking aides.</p>

<p>Solution: Reposition dropped kerb to align crossing.</p>	<p>Solution: Provide crossing facilities.</p>	<p>Solution: Provide fence around overhanging structure.</p>	<p>Solution: Provide dropped kerb for wheelchair users to access footpath.</p>
865 - Uneven paving / footway	875 - Broken paving / footway		
<p>This is located on Emmet Road. It is considered high severity due to the presence of a trip hazard which could result in a fall down hazardous steps.</p>	<p>This is located on Emmet Road. It is considered high severity due to the presence of a substantial hazard which could result in a dangerous fall.</p>

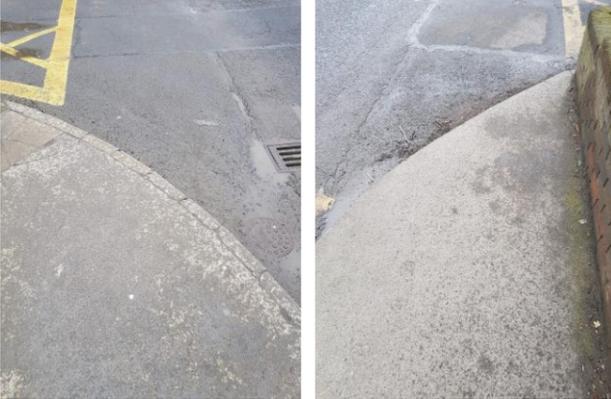
598 - No crossing facilities provided	604 - No crossing facilities provided	608 - No tactile paving at crossing	612 - Crossings not aligned
<p>This is located on Mount Brown outside St. James's Hospital. It is considered high severity as there are no alternatives to crossing at this point and it makes crossing inaccessible.</p>	<p>This is located on Mount Brown outside St. James's Hospital. It is considered high severity as there are no alternatives to crossing at this point and it makes crossing inaccessible.</p>	<p>This is located on James's Street east of St. James's Hospital. It is considered high severity as a lack of tactile paving makes visually impaired pedestrians unaware of the presence of the crossing.</p>	<p>This is located on James's Street east of St. James's Hospital. It is considered high severity due to the risk of visually impaired pedestrians walking into the carriageway while trying to use the crossing.</p>

<p>713245, 733703</p>	<p>713476, 733760</p>	<p>713595, 733798</p>	<p>713751, 733882</p>
<p>Solution: Provide crossing facilities.</p>	<p>Solution: Provide crossing facilities.</p>	<p>Solution: Provide required tactile paving.</p>	<p>Solution: Reposition dropped kerb to align crossing.</p>
<p>627 - No crossing facilities provided</p>			
<p>This is located on Thomas Street West. It is considered high severity as there are no alternatives to crossing at this point and it makes crossing inaccessible.</p>
