Appendix M1
Road Safety Audits
- Stage 1

BusConnects Dublin Core Bus Corridor Infrastructure Works – Package B

Road Safety Audit Stage 1

20/04/2022

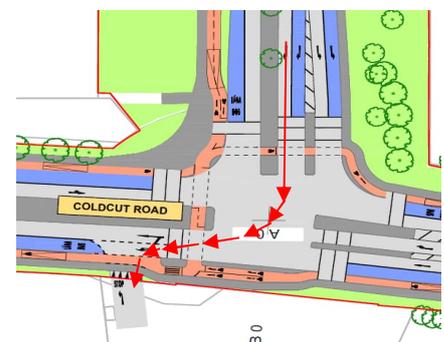
Figure 3.3 Access to Fitness Centre

It is noted that there is a left turn access for Liffey Valley Fitness (Figure 3.3). The Audit Team is concerned that motorists from the north wishing to access this facility may conflict with a bus mid junction resulting in a sideswipe type collision.

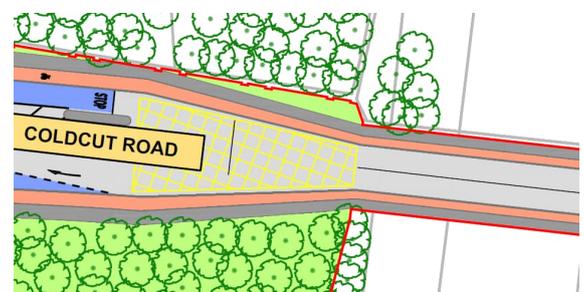
Figure 3.4 M50 Overbridge

It is noted that there are proposed footway and cycle track in each direction over the M50 overbridge. The proposed cycle track and footpath widths are 2.75m and the Audit Team are concerned that these widths may be below desirable minimum levels resulting in an increased risk of conflict between pedestrians and cyclists.

The design team should review the swept path analysis at this location to ensure that longer vehicles can pass one another safely across the bridge.

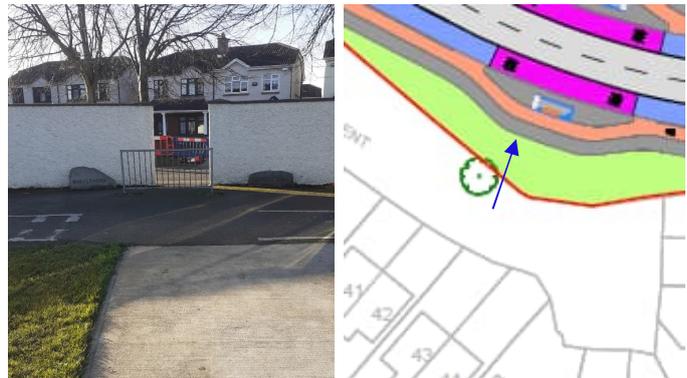
Figure 3.5 Pedestrian desire line

At the new island bus stop at chainage B680, its noted that the footway at this location has been moved to the roadside of the green space from the rear in the existing scenario. There is an existing formal pedestrian walkway facilitating a desire line to the adjacent residential development through. The Audit Team is concerned of an increased risk of trips and falls from pedestrians walking in the grassed area.

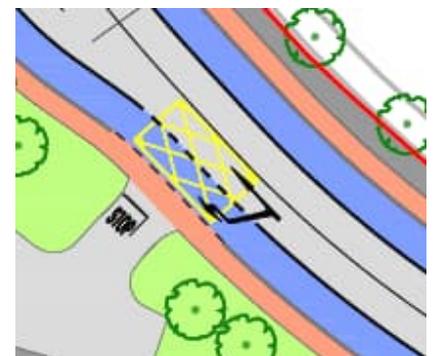
Figure 3.6 Box Junction

It is noted that there is a box turn across the northbound general traffic lane and bus lane. The Audit Team is concerned that, as the box turn doesn't cover the southbound general traffic lane as is currently the case, driver frustration may result in motorists making erratic movements resulting in sideswipe collisions.

The Design Team should extend the box junction across the inbound traffic lane.

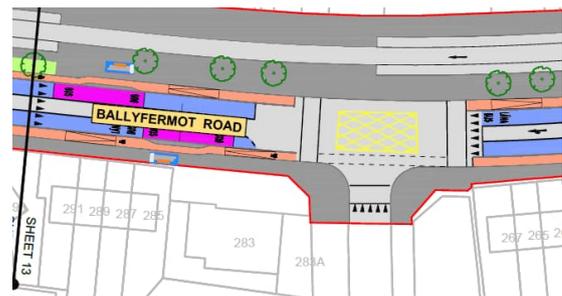
Figure 3.13 Raised Table

A raised table is indicated between chainage B2570 and B2750. Within the raised table, ramped cycle tracks are proposed. In the absence of drainage drawings, the Audit Team is concerned that water will pond between the raised table and adjacent ramps for cycle track causing a slipping hazard during cold conditions.

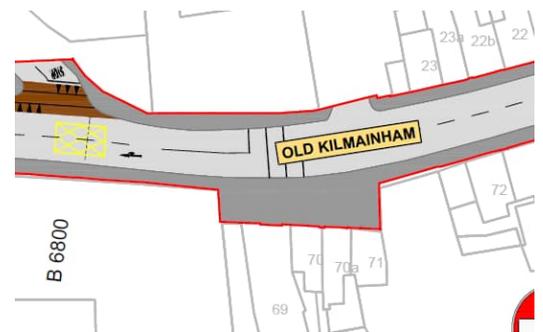
Figure 3.33 Pedestrian Crossing

It is noted that a new pedestrian crossing is proposed at chainage B6850 which is at a narrow bend in the road with compromised sightlines. The Audit Team are concerned that the primary signal head on the northern side of the street may not be visible to eastbound traffic as it is on the inside of the bend and the footway is narrow. This may lead to pedestrians crossing the street being struck by cars.

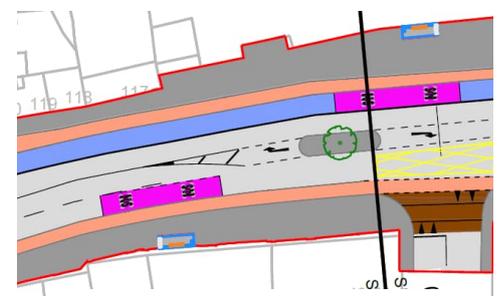
Figure 3.43 In-line Bus Stops

It is noted that there are a number of inline bus stops proposed between Chainage B7850 to 8700 (Sheets 25 to 27). In the absence of further detail, it is not clear if passengers should board/alight from the bus on the cycleway. The Audit Team are concern this will result in an increased risk of conflict between pedestrian/passengers and cyclists.

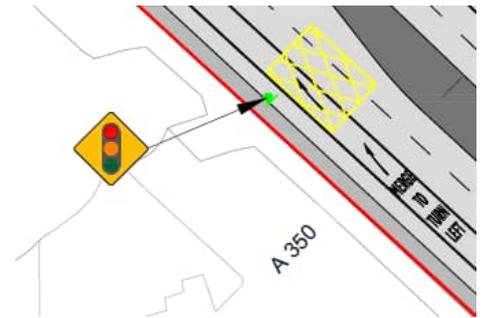
At a number of locations throughout the scheme, vehicles travelling in the bus lane which wish to turn left must merge into normal traffic on the right, so that they may complete the left turn manoeuvre. Where this manoeuvre is required, bespoke "merge to turn left" road markings are proposed, along with yellow box provision and M 101 Deflection Arrows. Such road markings are typically located a short distance from junctions, where they may be obscured by queuing traffic. A failure to observe these road markings may lead to vehicles attempting to turn left from the bus lane, which is not accommodated by the proposed signal phasing.

Figure 9-1 - Lack of signage re: merging to turn left

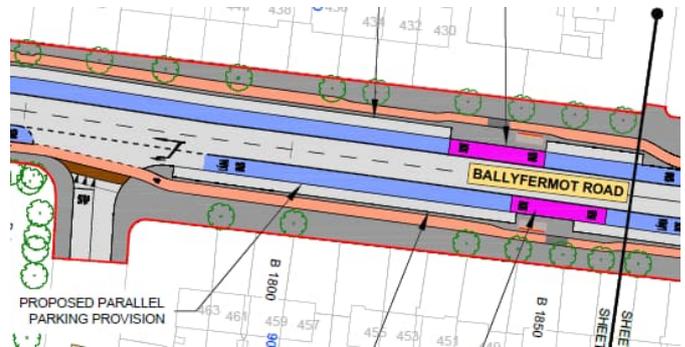
Figure 9-4 - Ballyfermot Road Parallel Parking Across Existing Driveways

The Design Team should remove on street parking which conflicts with existing private access and driveways.

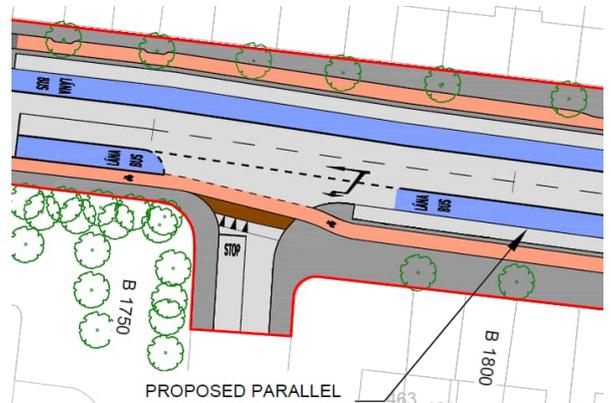
Figure 9-6 - Impact of parallel parking on junction intervisibility splay (Blackditch Dr/ Ballyfermot Rd)

The Design Team should shorten the proposed length of parallel parking away from side road junctions to promote intervisibility between cyclists and motorised vehicles.

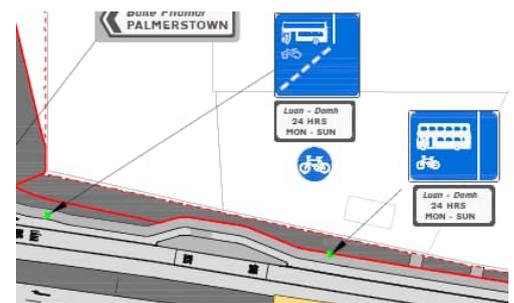
Figure 9-8 - Bus signage where segregated cycle lane provision (Coldcut Rd Ch B 50)

The design team should remove the cycle symbol from proposed bus lane signage, where it is not intended for cyclists to share the bus lane facility.

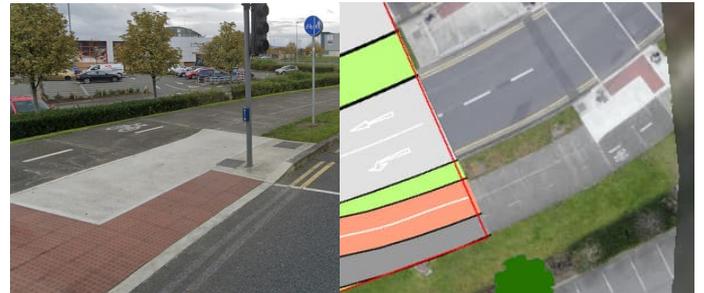
At the eastern arm of the Fonthill Road junction, the proposed pedestrian and cycle facilities do not match the existing arrangement at the tie in point. This may lead to conflict between pedestrians and cyclists.

Figure 10-2 - Existing cross section has footpath adjacent to verge and two way cycle lane on the outside

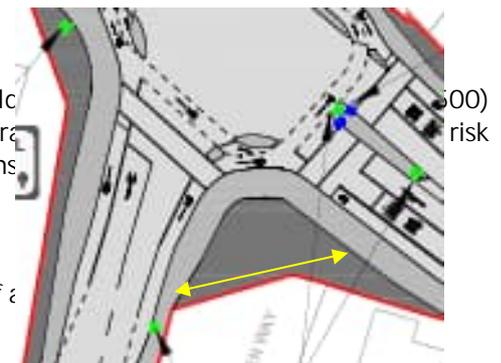
Figure 10-5 - Pedestrian Desire Line

The existing grassed area in the Southeast corner of the junction of Coldcut Road and Ballyfermot Road show an existing pedestrian desire line cutting the corner across the grass, leading to a risk of trips and slips for pedestrians crossing this area during wet conditions.

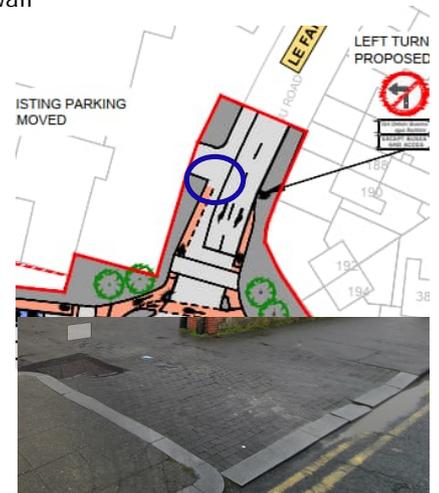
Figure 10-9 – Reduction in pedestrian priority

The design team should revert to the existing layout and give priority to pedestrians.

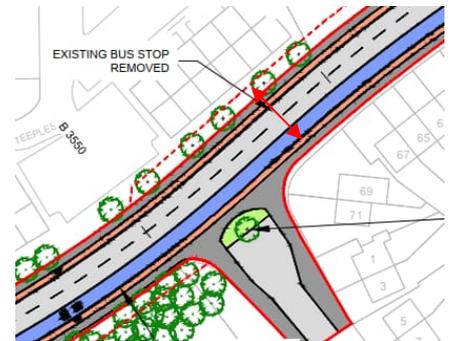
Figure 10-11 - Existing formal crossing removed as part of proposed scheme

The Design Team should consider the retention of a crossing facilities at this location.

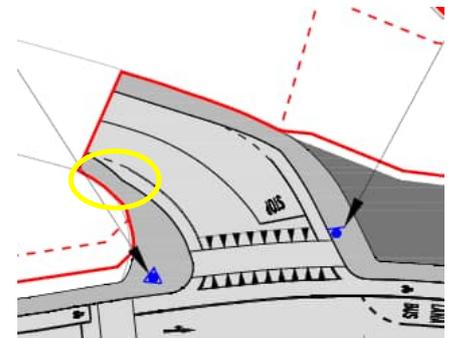
Figure 10-12 - Lack of signage for end of cycle facility

The Design Team should provide "Cycle Track Ends" signage RUS 009 with Supplementary Plate P 010 and appropriate yield road markings at this location.

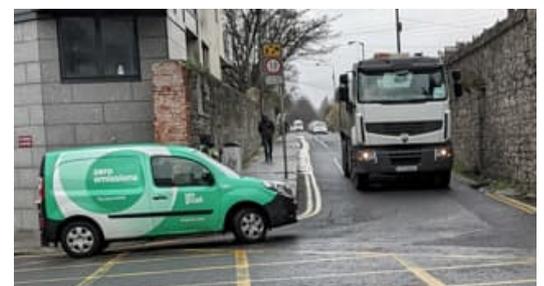
The junction of Grattan Crescent and Inchicore Terrace (Chainage B 5500) is a sharp hairpin turn onto the narrow cross section of Inchicore Terrace. During the site visit HGV traffic was observed to block Inchicore Terrace while waiting to turn onto Grattan Crescent, preventing other waiting vehicles from accessing Inchicore Terrace.

Figure 10-15 - HGV blocking access

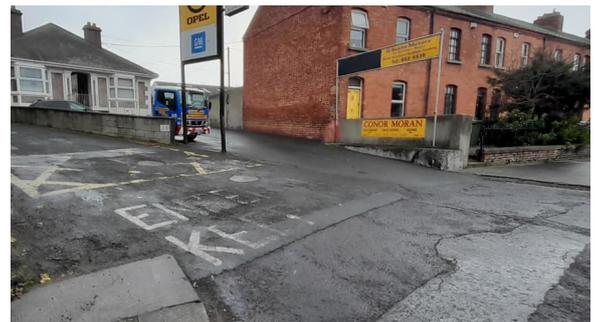
Figure 10-16 - Proximity of two adjacent entrances

New "STOP" road marking is proposed at an existing dual HGV access off Emmet Road. The road marking extends close to an existing wall separating the two entrances, making it difficult for a vehicle exiting from the right-hand property to manoeuvre safely over to the left-hand side before the start of the marking. The addition of this new road marking may leave vehicles entering the site to believe they have a larger designated entrance area, leading to side-on collisions with the vehicles exiting from the right.

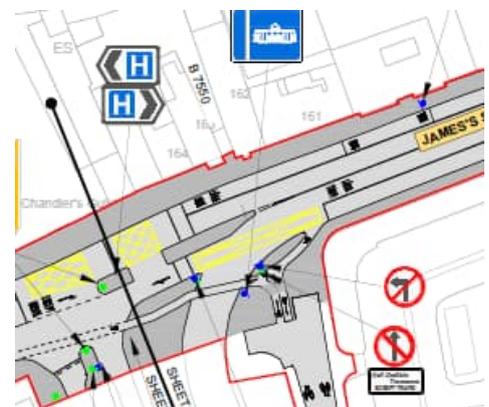
The design includes a proposed "Quiet Street" route for cyclists along Ewington Lane (B 7550), St. James's Avenue, Grand Canal Place and Echlin Street, in place of cyclists using James's Street. The design does not appear to include any advanced directional signage advising cyclists to take this route, which may result in them staying on James's Street, where no provision for cyclists is proposed.

Figure 10-17 - Lack of signage for "quiet street" route

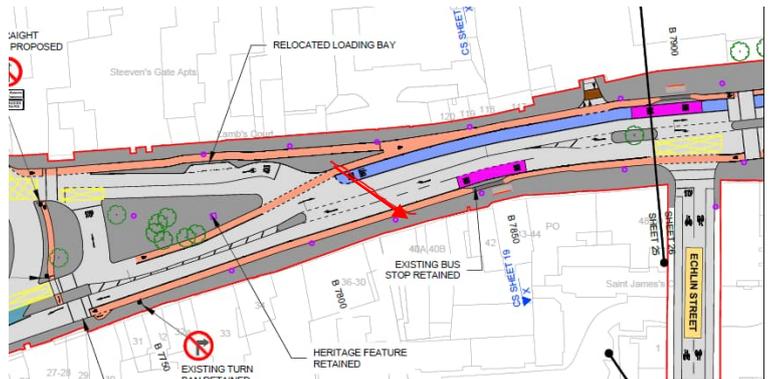
The proposed design at the junction of Echlin Street and James's Street does not include for crossing facilities on the western approach to the junction. Crossing facilities are also proposed at the junction with the Luas tracks at Bow Lane West but these do not align to the desire line of pedestrians wishing to travel to / from James's Street further east. A lack of crossing facilities in this location may result in pedestrians crossing where no facilities are to be provided (which was observed on site where pedestrians utilised traffic islands on James St), increasing the risk of conflict between pedestrians and vehicles.

Figure 10-21 - Observed Desire Line shown in red

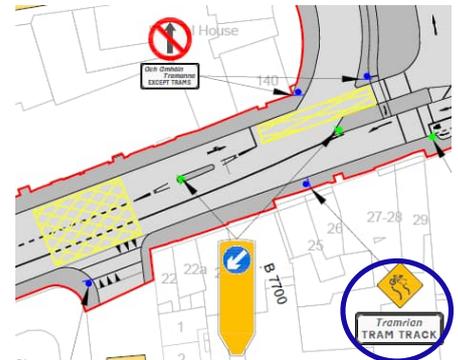
The LUAS tracks turning from James's Street towards Heuston Station (by Bow Lane West), cut across the traffic lane in a curve. Where cyclists are using the traffic lane (not taking the "Quiet Street" option), there is a risk that bicycle wheels may get trapped in the LUAS rails, causing cyclists to lose control.

Figure 10-22 - Lack of Tram Track Signage Eastbound compared to westbound cyclists

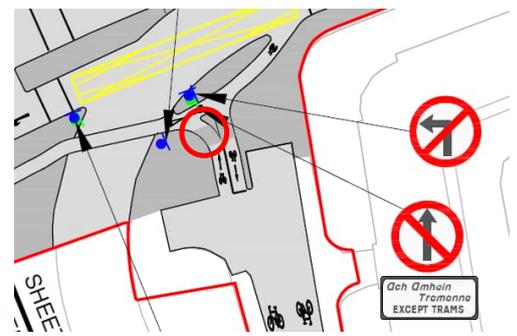
Figure 10-23 - Lack of road markings to indicate who has priority

The Design Team should include yield markings on one of the two stretches of cycle facilities described above.

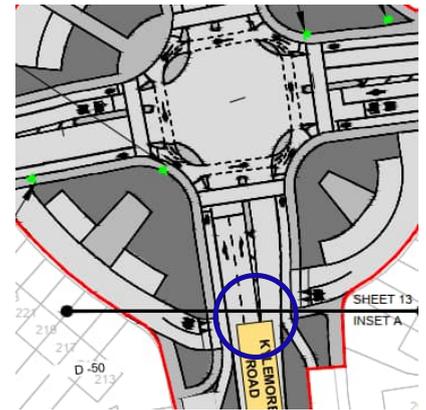
Figure 11. 1 Lack of Yellow Box

The design team should include a yellow box on approach to the junction opposite the two combined accesses to facilitate vehicles exiting onto Kylemore Road.
