Accessibility

Audit Report

BusConnects Radial Core Bus Corridors Infrastructure Upgrade Programme – Project B

Liffey Valley to City Centre Core Bus Corridor -Accessibility Audit Report

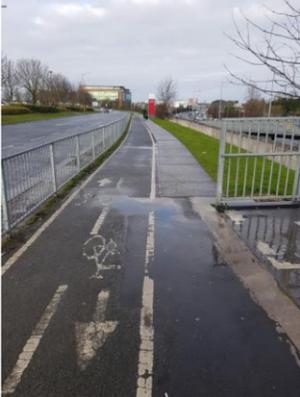
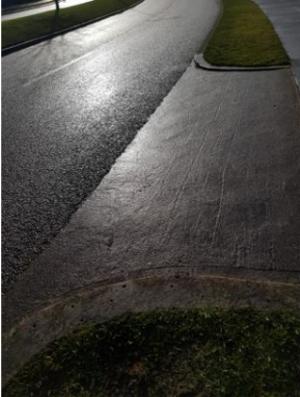
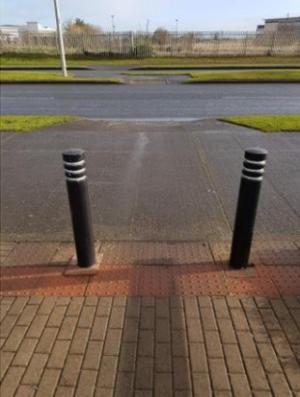
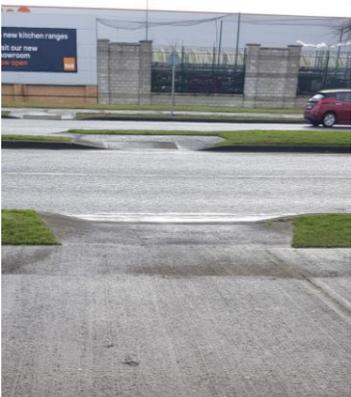
<p>341 - No level difference between footpath and cycle lane</p>	<p>364 - Inappropriately constructed vehicle crossover point (due to driveway being flush with road)</p>	<p>374 - No tactile paving at crossing – path crosses cycle lane</p>	<p>381 - No tactile paving at crossing</p>
<p>This is located within the Liffey Valley shopping centre road network, near the start of the route. It is considered high severity due to the risk of collision between pedestrians and cyclists.</p>	<p>This is located within the Liffey Valley shopping centre road network. It is considered high severity due to the risk of visually impaired pedestrians not being aware of the presence of a kerb and veering into the carriageway.</p>	<p>This is located within the Liffey Valley shopping centre road network. It is considered high severity due to the risk of collision between pedestrians and cyclists.</p>	<p>This is located within the Liffey Valley shopping centre road network. It is considered high severity as a lack of tactile paving makes visually impaired pedestrians unaware of the presence of the crossing.</p>

<p>707169,735144 (Map 1)</p>	<p>706810,734716 (Map 3)</p>	<p>707028,73452 (Map 4)</p>	<p>707177,734355 (Map 5)</p>
<p>Solution: Create delineation between the footpath and cycle path.</p>	<p>Solution: Raise the driveway to meet the required standard height.</p>	<p>Solution: Provide required tactile paving for those crossing the path to determine the difference between the cycle path and the footpath.</p>	<p>Solution: Provide required tactile paving.</p>
<p>383 - No tactile paving at crossing</p>	<p>384 - No tactile paving at crossing</p>	<p>385 - No tactile paving at crossing</p>	<p>639 - No crossing facilities provided</p>
<p>This is located within the Liffey Valley shopping centre road network, near the start of the route. It is considered high severity as a lack of tactile paving makes visually impaired pedestrians unaware of the presence of the crossing.</p>	<p>This is located within the Liffey Valley shopping centre road network, near the start of the route. It is considered high severity as a lack of tactile paving makes visually impaired pedestrians unaware of the presence of the crossing.</p>	<p>This is located within the Liffey Valley shopping centre road network, near the start of the route. It is considered high severity as a lack of tactile paving makes visually impaired pedestrians unaware of the presence of the crossing.</p>	<p>This is located within the Liffey Valley shopping centre road network, near the start of the route. It is considered high severity as a lack of a crossing at this point requires an unreasonable diversion and makes crossing inaccessible.</p>

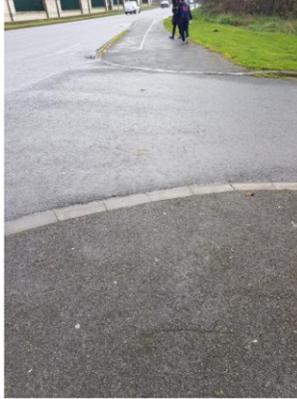
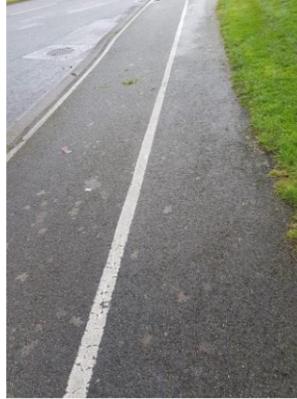
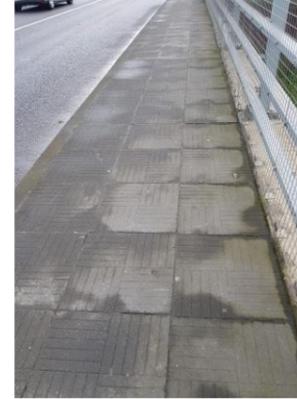
<p>392 - No tactile paving at crossing</p>	<p>394 - No level difference between footpath and cycle lane</p>	<p>396 - Unsuitable access for users with disabilities</p>	<p>397 - Uneven paving / footway</p>
<p>This is located on Coldcut Road just west of the M50. It is considered high severity as a lack of tactile paving makes visually impaired pedestrians unaware of the presence of the crossing.</p>	<p>This is located on Coldcut Road just west of the M50. It is considered high severity due to the risk of collision between pedestrians and cyclists.</p>	<p>This is located on Coldcut Road just west of the M50. It is considered high severity due to the risk of collision between pedestrians and cyclists.</p>	<p>This is located on Coldcut Road on the bridge above the M50. It is considered high severity due to the presence of trip hazards close to the kerb which could result in a fall into traffic. The area also has high noise levels which could make it more difficult for pedestrians to hear hazards.</p>

<p>707288,734233</p>	<p>707320,734235</p>	<p>707411,734225</p>	<p>707444,734222</p>
<p>Solution: Provide required tactile paving.</p>	<p>Solution: Create delineation between the footpath and cycle path.</p>	<p>Solution: Provide tactile paving to indicate the change from shared path to seperated cycle path and footpath.</p>	<p>Solution: Implement more suitable paving which is even.</p>
<p>398 - Unsuitable access for users with disabilities</p>	<p>402 - No tactile paving at crossing</p>	<p>411 - Unsuitable access for users with disabilities</p>	<p>412 - No level difference between footpath and cycle lane</p>
<p>This is located on Coldcut Road just east of the M50. It is considered high severity due to the risk of collision between pedestrians and cyclists.</p>	<p>This is located on Coldcut Road just east of the M50. It is considered high severity as a lack of tactile paving makes visually impaired pedestrians unaware of the presence of the crossing.</p>	<p>This is located on Coldcut Road just east of the M50. It is considered high severity due to the risk of collision between pedestrians and cyclists.</p>	<p>This is located on Coldcut Road just east of the M50. It is considered high severity due to the risk of collision between pedestrians and cyclists.</p>

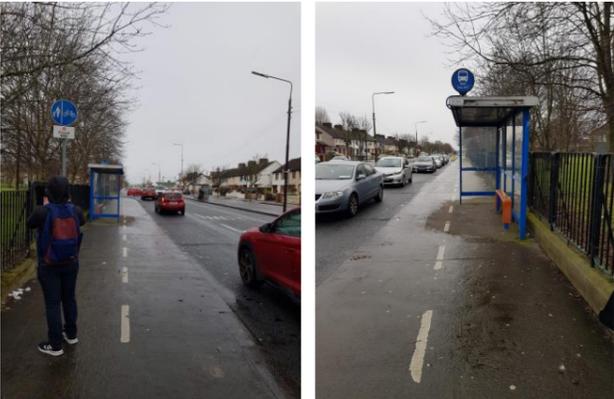
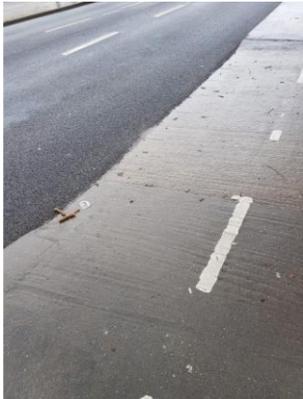
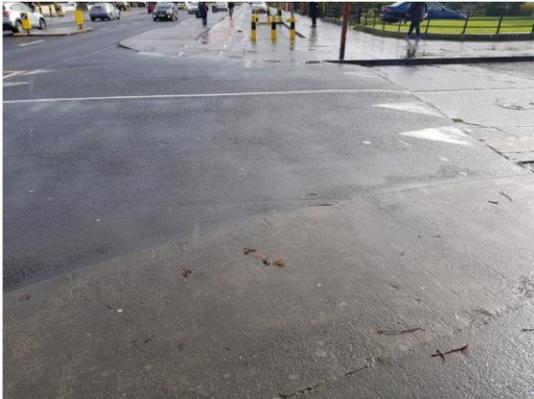
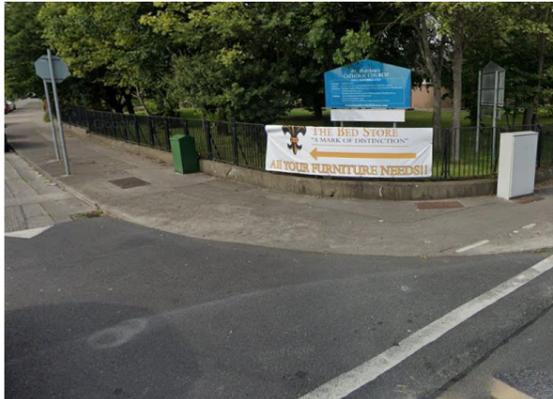
<p>708104,733905</p>	<p>708585,733821</p>	<p>708620,733818</p>	<p>708648,733815</p>
<p>Solution: Implement more suitable paving which is even.</p>	<p>Solution: Raise the driveway to meet the required standard height.</p>	<p>Solution: Create delineation between the footpath and cycle path.</p>	<p>Solution: Provide required tactile paving.</p>
443 - Inappropriate street furniture	444 - Inappropriately constructed vehicle crossover point	446 - No crossing facilities provided (both sides of the crossing)	447 - No crossing facilities provided
<p>This is located on Ballyfermot Road east of Cherry Orchard Hospital. It is considered high severity due to the risk of collision between pedestrians and cyclists.</p>	<p>This is located on Ballyfermot Road east of Cherry Orchard Hospital. It is considered high severity due to the risk of visually impaired pedestrians not being aware of the presence of a kerb and veering into the carriageway.</p>	<p>This is located on Ballyfermot Road east of Cherry Orchard Hospital. It is considered high severity as there are no alternatives to crossing at this point and it makes crossing inaccessible.</p>	<p>This is located on Ballyfermot Road east of Cherry Orchard Hospital. It is considered high severity as there are no alternatives to crossing at this point and it makes crossing inaccessible.</p>

<p>708679,733810</p>	<p>708792,733817</p>	<p>708839,733792</p>	<p>708857,733792</p>
<p>Solution: Improve the interaction between the cycle path, footpath and bus stop.</p>	<p>Solution: Raise the driveway to meet the required standard height.</p>	<p>Solution: Provide crossing facilities.</p>	<p>Solution: Provide crossing facilities.</p>
448 - Inappropriately constructed vehicle crossover point	449 - Vehicles parked in footway	452 - Incorrect tactile paving at crossing	
<p>This is located on Ballyfermot Road east of Cherry Orchard Hospital. It is considered high severity due to the risk of visually impaired pedestrians not being aware of the presence of a kerb and veering into the carriageway.</p>	<p>This is located on Ballyfermot Road east of Cherry Orchard Hospital. It is considered high severity as it makes the path inaccessible to people using wheelchairs or walking aides.</p>	<p>This is located on Ballyfermot Road east of Cherry Orchard Hospital. It is considered high severity as incorrect tactile paving makes visually impaired pedestrians unaware of the type of crossing and could lead to dangerous crossing movements.</p>

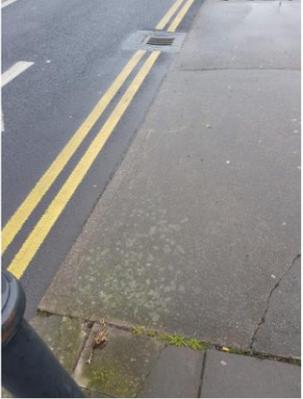
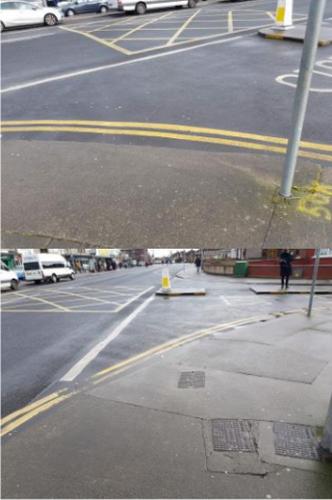
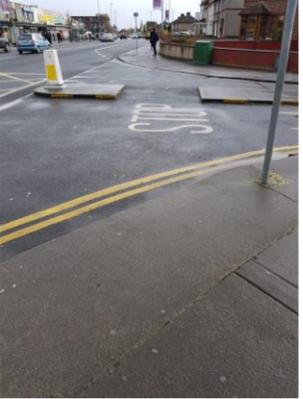
<p>469 - Inappropriately constructed vehicle crossover point</p>	<p>473 - Crossings not aligned</p>	<p>474 - No tactile paving at crossing</p>	<p>743 - No crossing facilities provided</p>
<p>This is located on Ballyfermot Road. It is considered high severity due to the risk of visually impaired pedestrians not being aware of the presence of a kerb and veering into the carriageway.</p>	<p>This is located on Ballyfermot Road. It is considered high severity due to the risk of visually impaired pedestrians walking into the carriageway while trying to use the crossing.</p>	<p>This is located on Ballyfermot Road. It is considered high severity as a lack of tactile paving makes visually impaired pedestrians unaware of the presence of the crossing.</p>	<p>This is located on Ballyfermot Road. It is considered high severity as there are no alternatives to crossing at this point and it makes crossing inaccessible.</p>

<p>709494,733716</p>	<p>709615, 733711</p>	<p>709613, 733708</p>	<p>709501, 733731</p>
<p>Solution: Raise the driveway to meet the required standard height.</p>	<p>Solution: Reposition dropped kerb to align crossing.</p>	<p>Solution: Provide required tactile paving.</p>	<p>Solution: Provide crossing facilities.</p>
<p>486 - No tactile paving at crossing</p>	<p>488 - No tactile paving at crossing</p>	<p>503 - No tactile paving at crossing</p>	<p>508 - Crossings not aligned</p>
<p>This is located on the Ballyfermot Road / Kylemore Road roundabout. It is considered high severity as a lack of tactile paving makes visually impaired pedestrians unaware of the presence of the crossing.</p>	<p>This is located on the Ballyfermot Road / Kylemore Road roundabout. It is considered high severity as a lack of tactile paving makes visually impaired pedestrians unaware of the presence of the crossing.</p>	<p>This is located on Ballyfermot Road. It is considered high severity as a lack of tactile paving makes visually impaired pedestrians unaware of the presence of the crossing.</p>	<p>This is located on Ballyfermot Road. It is considered high severity due to the risk of visually impaired pedestrians walking into the carriageway while trying to use the crossing.</p>

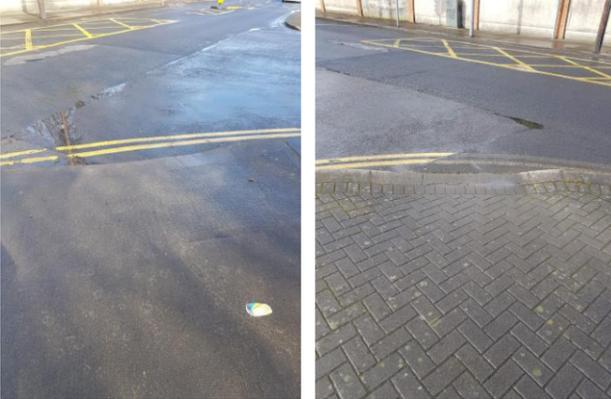
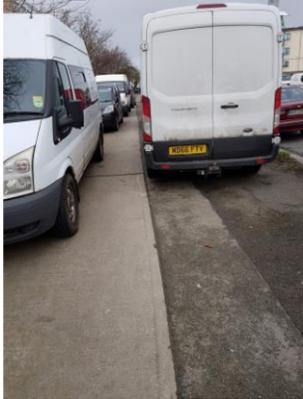
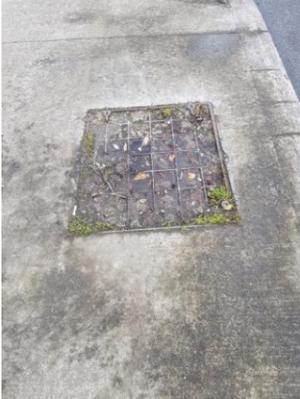
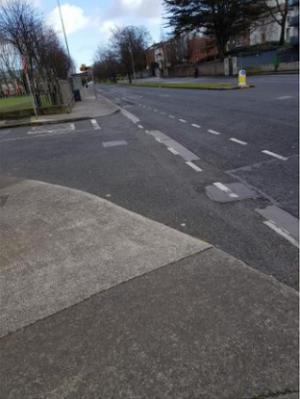
<p>709961, 733678</p>	<p>709988, 733713</p>	<p>710358, 733684</p>	<p>710603, 733730</p>
<p>Solution: Provide required tactile paving.</p>	<p>Solution: Provide required tactile paving.</p>	<p>Solution: Provide required tactile paving.</p>	<p>Solution: Reposition dropped kerb to align crossing.</p>
<p>509 - No tactile paving at crossing</p>	<p>770 - Vehicles parked in footway</p>	<p>810 - Uneven paving / footway</p>	<p>829 - Crossings not aligned</p>
<p>This is located on Ballyfermot Road. It is considered high severity as a lack of tactile paving makes visually impaired pedestrians unaware of the presence of the crossing.</p>	<p>This is located on Ballyfermot Road. It is considered high severity as it makes the path inaccessible to people using wheelchairs or walking aides.</p>	<p>This is located on Ballyfermot Road. It is considered high severity due to the presence of a trip hazard which could result in a fall into traffic.</p>	<p>This is located on Sarsfield Road. It is considered high severity due to the risk of visually impaired pedestrians</p>

<p>walking into the carriageway while trying to use the crossing.</p>

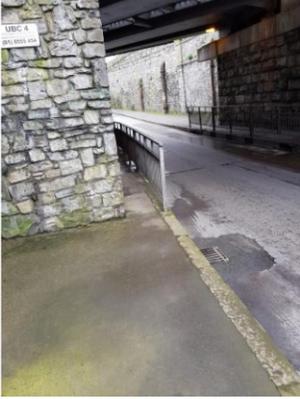
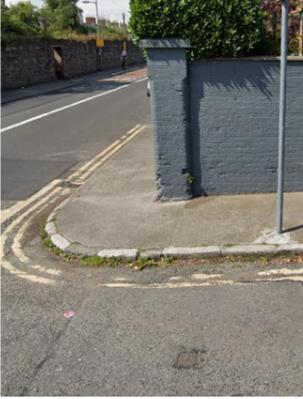
<p>710609, 733731</p>	<p>709849,733972</p>	<p>710659, 733789</p>	<p>711316, 733746</p>
<p>Solution: Provide required tactile paving.</p>	<p>Solution: Enforce no parking on footpath in this area.</p>	<p>Solution: Repair paving to make it smooth and no longer a trip hazard.</p>	<p>Solution: Reposition dropped kerb to align crossing.</p>
<p>838 - Insufficient footpath width</p>	<p>843 - No crossing facilities provided</p>		
<p>This is located on Inchicore Road under the railway bridge. It is considered high severity as it makes the path inaccessible to people using wheelchairs or walking aides.</p>	<p>This is located on Inchicore Road outside Woodfield Cottages. It is considered high severity as there are no alternatives to crossing at this point and it makes crossing inaccessible.</p>

<p>Solution: Build out footpath to provide sufficient width or provide crossing at this point for users to access the footpath on the other side of the road.</p>	<p>Solution: Provide crossing facilities.</p>

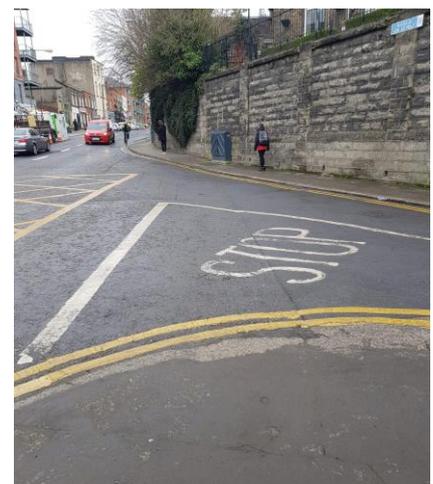
There were four crossing that had no facilities provided (Figure 6.4) and 12 with no tactile paving. There were 19 crossing points that had incorrect tactile paving. There were six crossings with dropped kerbs not flush with the road, four crossings with poor road surfacing and one crossing that was not aligned correctly. There was one push button that was incorrectly located.

Figure 6.4: No crossing facilities provided

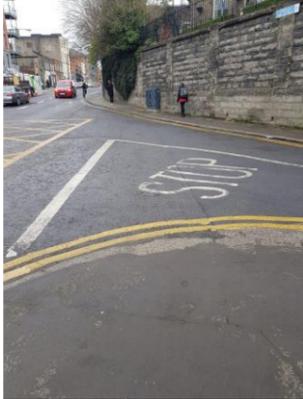
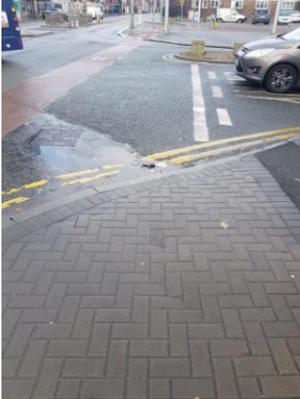
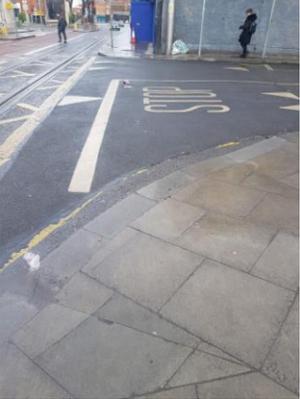
598 - No crossing facilities provided	604 - No crossing facilities provided	608 - No tactile paving at crossing	612 - Crossings not aligned
<p>This is located on Mount Brown outside St. James's Hospital. It is considered high severity as there are no alternatives to crossing at this point and it makes crossing inaccessible.</p>	<p>This is located on Mount Brown outside St. James's Hospital. It is considered high severity as there are no alternatives to crossing at this point and it makes crossing inaccessible.</p>	<p>This is located on James's Street east of St. James's Hospital. It is considered high severity as a lack of tactile paving makes visually impaired pedestrians unaware of the presence of the crossing.</p>	<p>This is located on James's Street east of St. James's Hospital. It is considered high severity due to the risk of visually impaired pedestrians walking into the carriageway while trying to use the crossing.</p>

<p>713245, 733703</p>	<p>713476, 733760</p>	<p>713595, 733798</p>	<p>713751, 733882</p>
<p>Solution: Provide crossing facilities.</p>	<p>Solution: Provide crossing facilities.</p>	<p>Solution: Provide required tactile paving.</p>	<p>Solution: Reposition dropped kerb to align crossing.</p>
<p>627 - No crossing facilities provided</p>			
<p>This is located on Thomas Street West. It is considered high severity as there are no alternatives to crossing at this point and it makes crossing inaccessible.</p>
