Appendix M1
Road Safety Audits
- Stage 1

BusConnects Dublin Core Bus Corridor Infrastructure Works – Package B

Road Safety Audit Stage 1

20/04/2022

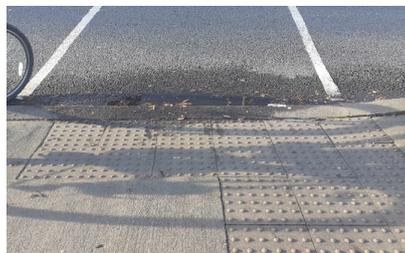
Figure 2.1 Pedestrian Crossing at Liffey Valley SC

The Audit Team noted evidence of potential ponding of water in the carriageway at various locations. The widening of the carriageway to facilitate additional lanes may increase the risk of ponding of water increased the risk of loss of control type collision due to ice during cold conditions.

The Design Team should ensure the drainage design is sufficient to positively drain the carriageway and that gullies are provided upstream of pedestrian crossings.

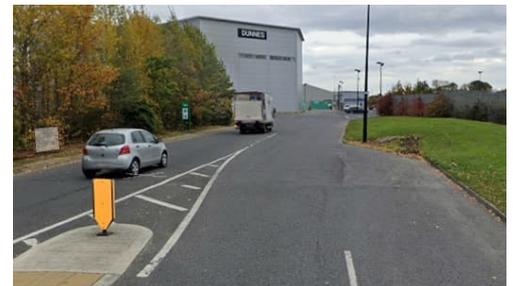
The Audit Team note that on the north-eastern approach to the junction that there are 2 lanes of traffic at the tie in and at the Stop lane. The existing road layout, just outside the scheme extents at the tie-in has an abrupt road widening into 2 lanes. This abrupt widening with missing kerbing may lead to an increased risk driver confusion (Figure 3.2).

Figure 3.2 Missing kerb on approach to junction

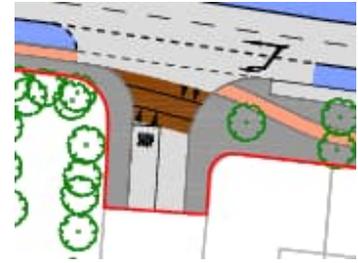
The Audit Team note the westbound cycle lane before Blackditch Drive is set back from the carriageway and transitions back to immediately adjacent to the bus lane across the apron of Blackditch drive junction, a priority junction. It is not clear who has the level of priority here and. As the upstream cycle track is set behind the trees and parallel parking bays, motorists and cyclists may be confused as to who has priority here resulting in an increased risk of motorist/ cyclist conflicts (Figure 3.7).

Figure 3.7 Cycle track transition

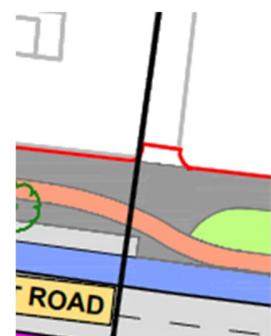
The Audit Team note there is vehicular access, albeit it narrow, to numbers 1-11B Cleggan road from the scheme but it is not clear how motorists will still access this safely across the transitioning cycle track (Figure 3.8).

Figure 3.8 Cycleway transition

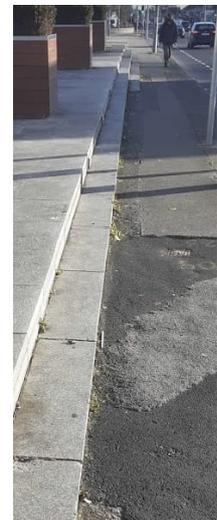
Granite steps along the front of the Community Civic Center are noted at chainage B2010. As the general paving area is level, and the carriageway slopes inbound (figure 3.09), there is a gradual creation of steps across the front of the civil area outside the centre. The Audit Team is concerned this creates a tripping hazard. There is also uneven surface increasing tripping hazard adjacent to the steps. (Figure 3.10)

Figure 3.10 Steps - Tripping hazard

The design team should ensure a safe footway for all users and highlight the hazard to the visually impaired through provision of appropriate tactile paving.

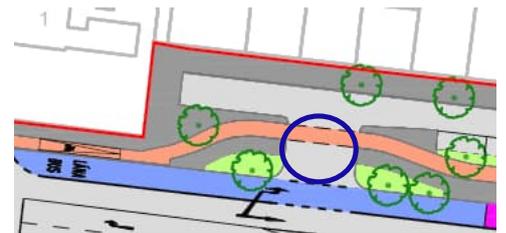
The Audit Team note the cycle track diverges away from the main carriageway at chainage B2150. At this point the cycle track ramps up but, in the absence of a raised table here, it is not clear at what level the cyclist crosses the private access. The Audit Team are concerned that the abrupt level difference will be imperceptible to vehicle approaching. (Figure 3.11).

Figure 3.11 Cycle lane raised across private access

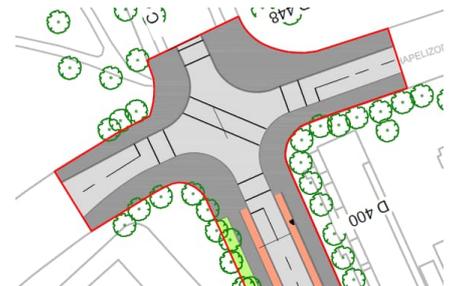
The Audit Team note that, in the context of the Junction Intervisibility Zone, that drivers at some of the stop lines at the junction in Figure 3.12 above will not be able to fully see the stop lines on other arms of the junction. This compromises visibility and safety of vulnerable road users resulting in the potential for injury by being struck by a vehicle.

Figure 3.12 Cycle tie on Kylemore Rd

The design team should review the end of the cycle track and provide a clear, distinguished tie-in for cyclists to progress beyond this point. (Figure 3.12)

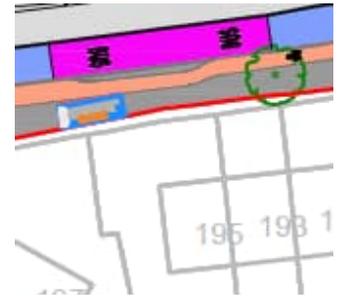
Figure 3.14 Bus Stop

A bus stop is proposed outside numbers 193/195 Ballyfermot Rd (Figure 3.14). In the absence of any detail pertaining to kassel kerbs, the Audit Team are unclear how existing vehicular access will be maintained to these properties and are concerned that motorists trying to access these properties may injure pedestrians, cyclists while mounting the kassel kerbs.

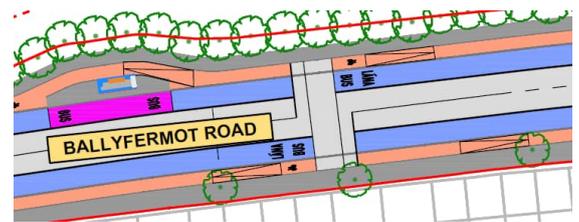
The Audit Team note that a signalised crossing is proposed outside number 171 Ballyfermot Rd. The Audit Team is concerned that the locations of the ramps, with regard to vehicular accesses on the southern side of Ballyfermot Rd and proximity to the island bus stop at the north may result in an increased risk tripping hazards for pedestrians or difficulties for motorists in accessing driveways.

Figure 3.15 crossing and cycle track ramps

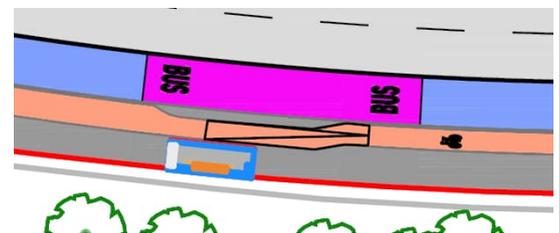
Figure 3.17 Bus stop ramp

The Design Team should revise the cycle track ramps in this location.

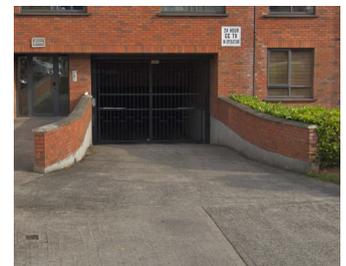
Figure 3.18 Car park access

An existing underground car park access point is noted at chainage B3670 (Figure 3.18). Due to the road widening at this location, it is not clear if there will be any impact on the dwell gradient of the existing access ramp or the visibility splay. The Audit Team is concerned that the road widening will result in a sudden change in gradient at this location or compromised visibility splay resulting in compromised sightlines for drivers.

The Design Team should review the gradient of this ramp in the context of road widening and visibility splays.

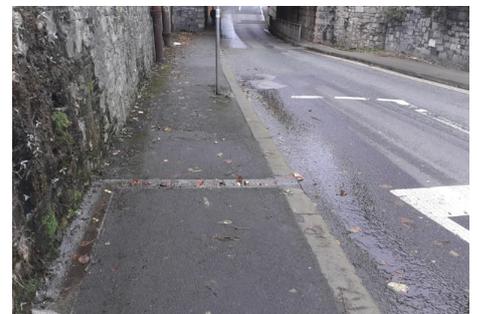
Site observation indicated surface water emerging from adjacent retaining walls, blocked gullies under the bridge and the existing/proposed slippery road surface sign. The Audit Team are concerned about the existence of water regularly flowing and ponding in the area causing a slipping hazard for pedestrians and increased risk of loss of control type collisions (Figure 3.21).

Figure 3.21 Water Flowing along Sarsfield Rd

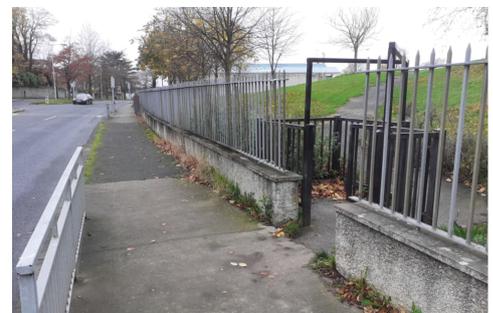
Figure 3.22 Park Gate

The Audit Team note that the existing access to East Timor park at B4570 has not been provided for in the proposed footway. The Audit Team are concerned that pedestrians will use the grass verge or cycle track at this point to access the park resulting in a slipping hazard or potential to be knocked down by a cyclist respectively.

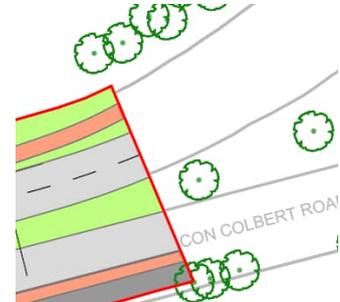
Figure 3.23 Cycle Scheme Tie-in

It is noted that the cycle track at the end of the scheme along Con Colbert Road does not tie-in to the adjacent road layout. The Audit Team are concerned that this may result in cyclist confusion and increased risk of conflict with motorists.

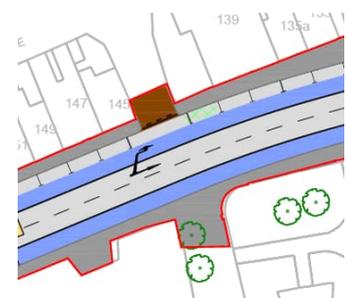
Figure 3.29 Removed Crossing

The Design Team should make provision for a pedestrian crossing, including traffic calming, at this location to maintain the existing desire line.

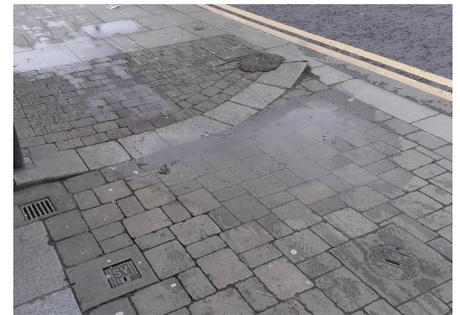
Figure 3.30 Ponding of water

The Design Team should ensure the drainage provision is adequate.

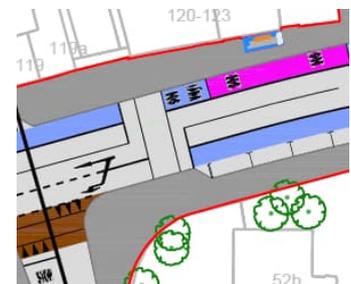
Figure 3.31 Impact on Bulfin Rd Visibility Splay

The Design Team should provide an appropriate visibility splay at this location or signalize this junction in conjunction.

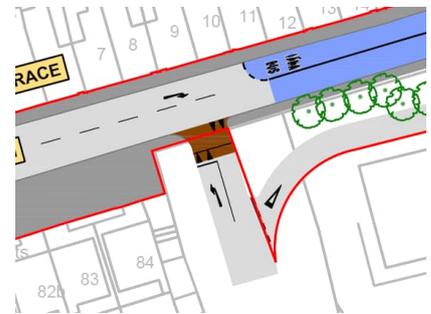
Figure 3.34 Narrow Raised Table

The Design Team should ensure the tabletop ramp is sufficiently wide to cover the pedestrian desire lines.

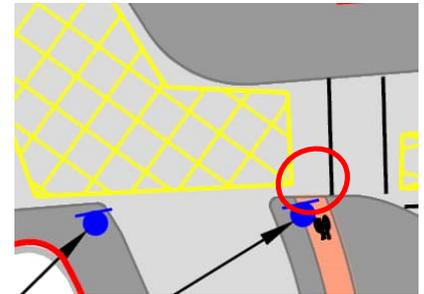
Figure 3.37 New Cycle Track

It is noted that a cycle track is proposed on the island at B7730 adjacent to the existing Luas line. It is not clear as to the direction of travel of the cycle or what the exact desire line is to access this is relative to vehicles and/or tram tracks or if signaling priority has been provided to access it. The Audit Team are concerned that there is a risk of:

1. Cyclists making dangerous maneuvers to access this with associated risks of being struck by a vehicle;
2. Cyclists striking the ill-positioned 'Tram Only' pole on entry;
3. Cyclists getting stuck in the parallel recessed tram tracks trying to enter the new cycle track;
4. Pedestrians using the existing pedestrian crossing over the Tram Lane to the west of this island may be struck by cyclists.

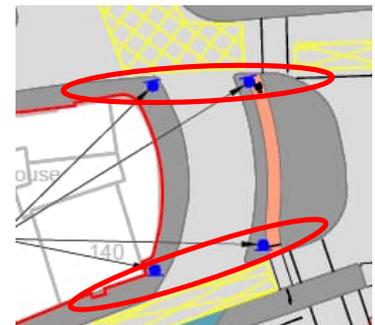
Figure 3.38 Unsignalised Crossings

The Design Team should consider how the interaction between pedestrians and cyclists will occur on this island.

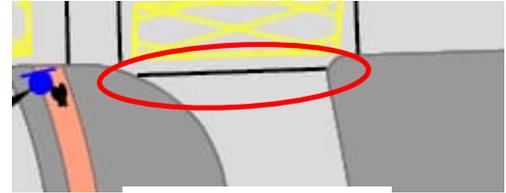
Figure 3.40 No Entry

It is noted that the existing 2-way link east of the tram tracks, at B7750, is to be replaced with a 1-way route. The northern end of this link does not have associated road markings and road signs outlining this. The Audit Team are concerned that existing traffic turning into this link will be unaware leading to an increased risk of head-on collisions.

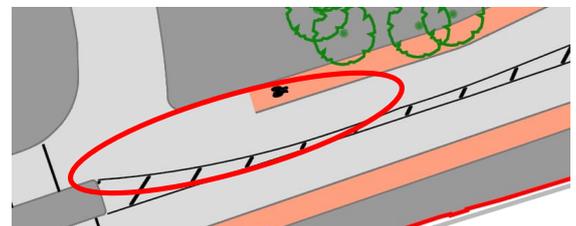
Figure 3.42 Vehicle Swept Path

It is noted that there is a new inbound cycle lane at B7750. In the absence of swept path analysis, it is not clear if vehicles (particularly buses) can adequately navigate past the commencement of the cycle lane. The Audit Team are concerned that cyclists may be sideswiped by buses.

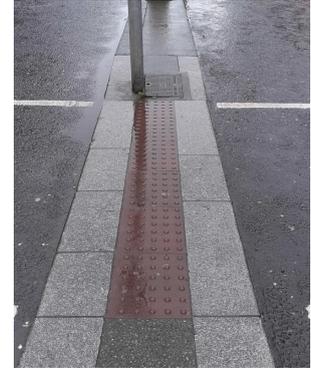
It is noted that the existing pedestrian crossing at B8750 has a very narrow central island which appears to be retained in the proposed drawings. During the site visit it was established that there is a single strip of tactile paving as shown. The Audit Team are concerned that visually impaired pedestrians crossing this will either step over it or be confused about its purpose.

Figure 3.47 Central Island

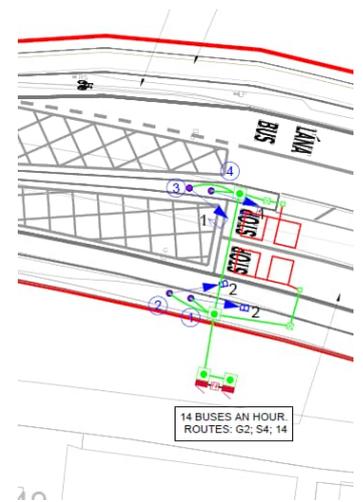
Figure 4.2 M50 Overbridge east

It is noted that on the eastern side of the bridge, there is no island separating the general traffic lane and bus lane and consequently there are no signal heads between the two lanes. As such, motorists may not be able to see the signal head for the bus lane and may get confused as to their priority and may pull away resulting in a sideswipe type collision. (Figure 4.2).

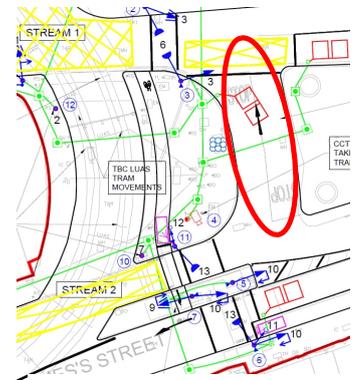
Figure 4.8 Lack of proposed signals

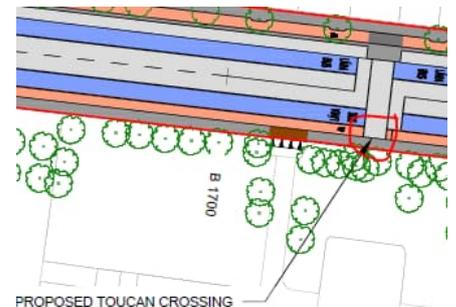
Figure 9-7 - Lack of Cyclist Waiting Area

The design team should provide cyclist waiting areas or shared pedestrian and cyclist areas in the vicinity of crossings where cycle lanes are being provided throughout the scheme.

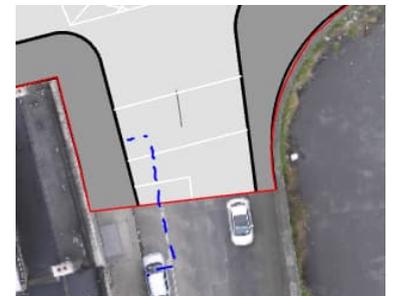
At a number of locations along the scheme, where new raised tables are being added at side road entrances, the STOP road markings are being moved further from the junction. These changes will impact on existing parallel parking on the side road. It is not clear from the drawings provided if new road marking will be provided outside the scheme tie-in point to delineate the new parking layout. This is particularly pertinent where the reduced parking is a loading bay. Confusion as to the location of the end of the permitted parking bays, or a reduced/insufficient space for vehicles loading/unloading may lead to parked vehicles encroaching on the junction, leading to conflicts with vehicles entering and existing the side road.

Figure 9-11 - Existing Loading Bay impacted upon by proposed road markings

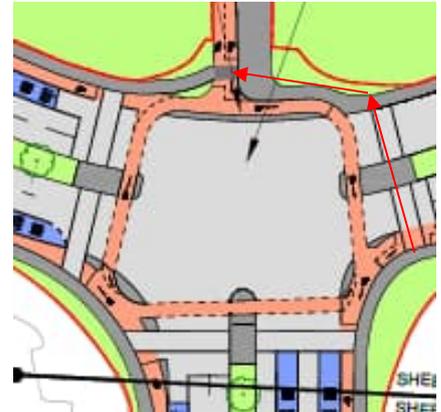
At the three arm junction of Fonthill Road, cyclists approaching from the east and wishing to turn right onto the two way cycle track north of the junction, will be required to wait for two signal phases in order to complete their manoeuvre. This may result in cyclists instead crossing at the pedestrian crossing, travelling a short distance against the direction of travel on the north side of the junction before continuing north on the cycle facility. This will increase the risk of conflict between cyclists and between cyclists and pedestrians.

Figure 10-1 - Scope for 2-way facility

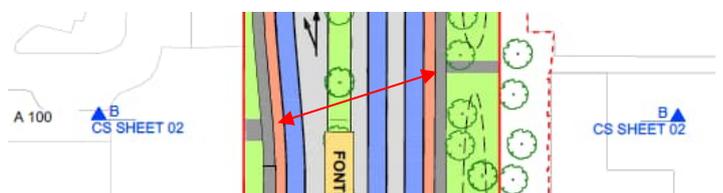
There is currently an uncontrolled pedestrian crossing at chainage A110 between two opposite pedestrian accesses on Fonthill Road, which is proposed to be removed as part of the design. This may lead to pedestrians crossing where no facilities have been provided. This problem was previously raised as a Problem 3.2.5 in the original RSA.

Figure 10-3 - Existing desire line/ existing uncontrolled crossing

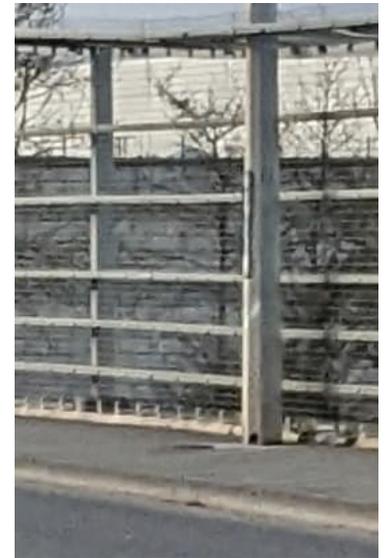
It is proposed that cyclists and pedestrians will share the existing footpath where the Coldcut Road crosses the M50, as per the current situation. The existing footpath on the bridge appears narrow for a shared pedestrian and cyclist facility, particularly on the northern side of the bridge where the available width is further constrained by the presence of two lighting columns located within the footpath. This leads to a risk of conflict between pedestrians and cyclists or cyclists swerving into trafficked lanes. This problem was previously raised as Problem 3.2.3 in the original RSA.

Figure 10-4 - Existing Public Lighting Configuration

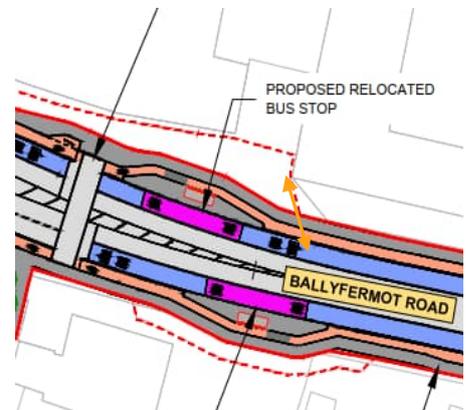
Figure 10-6 - Insufficient pedestrian provision

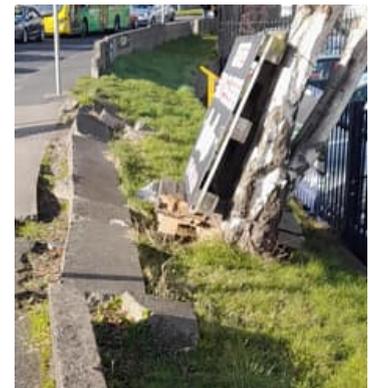
The existing boundary wall adjacent to the footpath on Ballyfermot Road is damaged with loose blocks at various locations. This could lead to an increased risk of trips and slips for pedestrians.

Figure 10-7 - Damaged boundary wall

The design team should ensure the repair and renewal of existing boundary infrastructure.

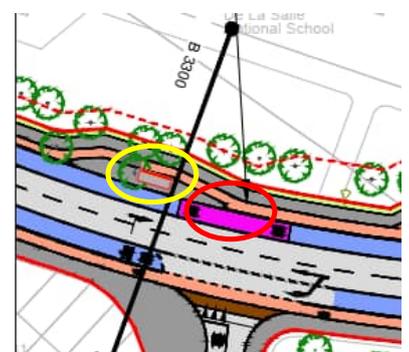
Figure 10-10 - Misalignment of Bus Shelter with Bus Stop Road Markings

The design team should review provision at this location, so that the proposed bus stop road marking is in line with the proposed bus shelter.

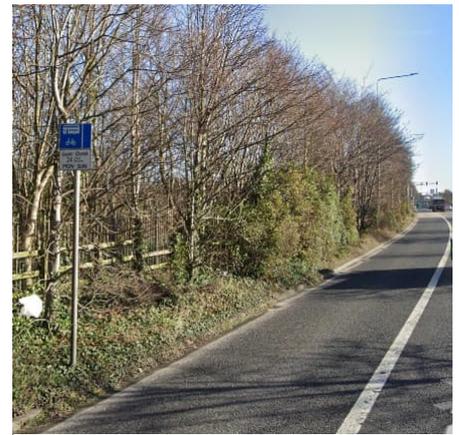
Figure 10-14 - Existing signage indicates cyclists eastbound approaching junction

The Design Team should ensure that appropriate crossing facilities are provided to accommodate cyclist movements at this location.

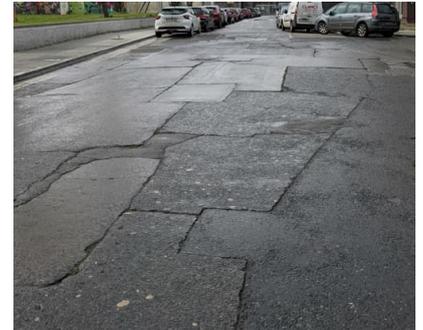
The design includes a proposed “Quiet Street” route for cyclists along Newington Lane, St. James’s Avenue, Grand Canal Place and Echlin Street, in place of cyclists using James’s Street. The existing road pavement along this route is patchy and broken with numerous potholes. If the proposed alternative route is not attractive to cyclists they are unlikely to use it, travelling instead along James St where no cycle facilities have been provided, increasing the risk of conflict between cyclist and other vehicles using James St.

Figure 10-18 - Poor condition of existing road surface along proposed quiet street

The Design Team should improve the condition of the existing road pavement along the proposed Quiet Route to encourage cyclists use it.

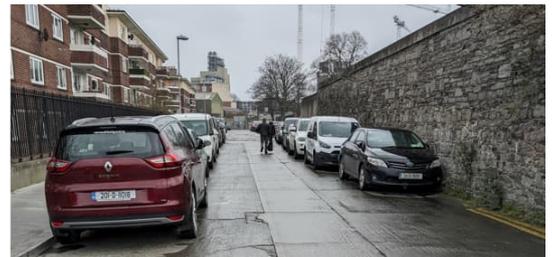
The design includes a proposed “Quiet Street” route for cyclists along Newington Lane, St. James’s Avenue, Grand Canal Place and Echlin Street, in place of cyclists using James’s Street. It was observed on site that cars were parked on both sides of Newington Lane. The remaining available carriageway width was not sufficient for a cyclist to pass an approaching car safely, and no room available for the cyclist to pull in out of the way, leading to possible head on collisions.

Figure 10-19 - Ad hoc parking along Newington Lane

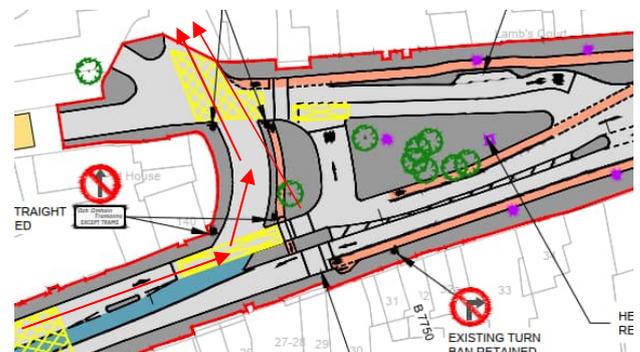
The Design Team noted Bow Lane West would be the preferred route for cyclists heading west from James St. However, it is unclear from the drawings what the proposed cycle route through the junction is from James St to Bow Lane West. There is a single cycle lane through the junction island heading from north to south but no provision is planned from south to north. There is no cycle lane or crossing facility from the central island to Bow Lane West across the LUAS tracks. A lack of clarity for cyclists on the correct route and lack of cycle track facilities through the junction may lead to cyclists making unsafe manoeuvres where there are no facilities provided, leading to risk of conflict between cyclists and vehicles.

Figure 10-20 - Insufficient Cycle provision to cater for desire lines

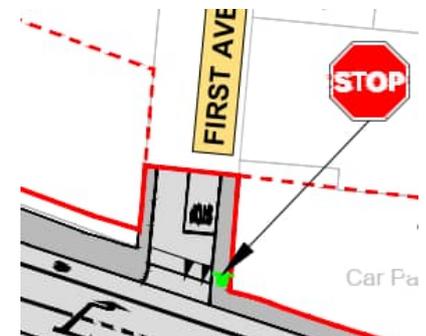
Junction visibility from the proposed STOP road marking location on First Avenue is blocked by the existing wall to the west of the junction. This may lead to unsafe turning movements and side on collisions with traffic on Sarsfield Road.

Figure 11. 2 Lack of sightline from stop location

The design team should move the STOP road marking closer to the junction and ensure full junction visibility from First Avenue onto Sarsfield Road.

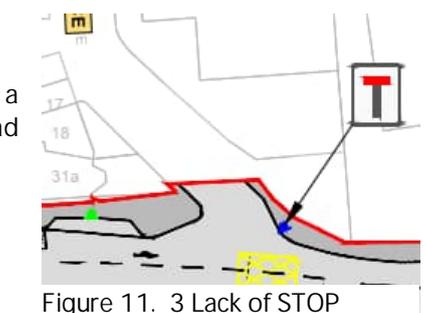
Figure 11. 3 Lack of STOP markings

The design team should include STOP road marking at this junction.

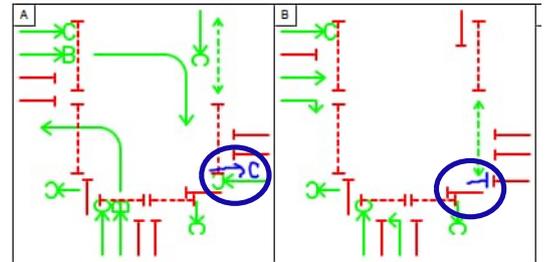
System diagrams A and B are missing the eastbound cycle movement onto Fonthill Road. Lack of specific signalling for this movement could lead to conflict between cyclists and pedestrians.

Figure 12. 1 Cycle phases missing from diagram

The design team should update system diagrams A and B to include all appropriate movements.

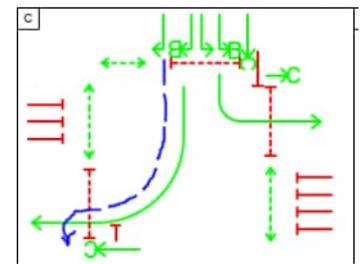
Figure 12. 2 Crossing movements

The design team should stagger the bus right turn and the general traffic right turn to avoid conflict.

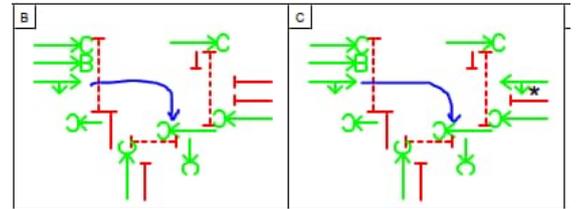
System diagram B and C does not show any * on the right turning movement for traffic from Ballyfermot onto Clifden Road. Lack of flashing amber on the right turn movement will not alert right turning traffic to be aware of cyclist or vehicles continuing straight on Ballyfermot Road in a westbound direction

Figure 12. 4 Lack of flashing amber

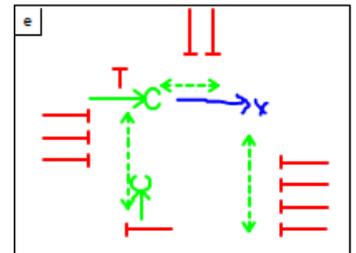
System diagram E shows a straight-ahead movement for cyclists travelling eastbound along Ballyfermot Road, while also showing the pedestrian crossing movement on the eastern arm of the junction. This could lead to conflict between cyclists and pedestrians.

Figure 12. 5 Conflicting pedestrian & cycle movements during same phase

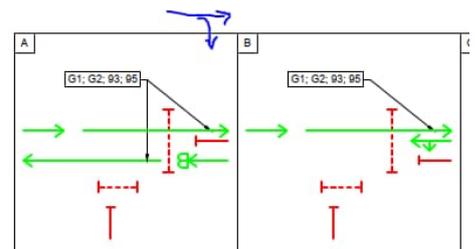
System diagrams A and B do not show any signal for the right turn movement from Emmet Road onto St Vincent Street West. This could lead to vehicles turning right at unsafe times, leading to conflict with oncoming vehicles.

Figure 12.8 Right turn movement not shown

The design team should ensure all junction movements are catered for within the system design diagrams.

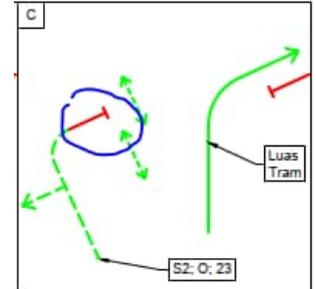
System diagrams C shows the right turn movement onto James's St stopping mid-junction at the pedestrian crossing. This could lead to rear end shunt collisions, or failure to stop with risk of conflict between vehicles and pedestrians.

Figure 12. 9 Right turn movement conflicting with pedestrians

The design team should stagger the right turn movement and the pedestrian crossing movement to reduce the risk of conflict.

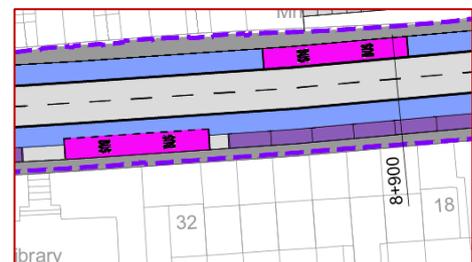
Summary: Unclear if adequate footpath width is proposed at all locations along the route, and in particular at proposed bus stop locations.

It is unclear from the information provided whether adequate footpath width is proposed at all locations along the route. In particular at proposed bus stop locations where waiting bus passengers, bus shelters and signage (e.g. RTPI signs) may reduce the effective footpath width.

Ensure that adequate footpath width has been provided at all locations along the route to cater for the expected volumes of pedestrians and taking account of the likely items of roadside furniture to be provided (e.g. bus shelters, signage, etc.).

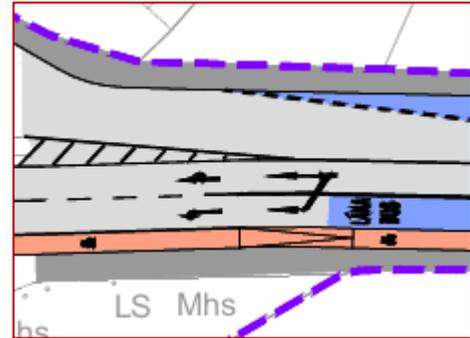
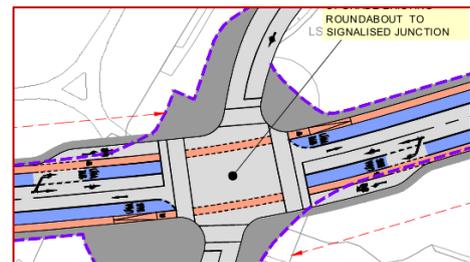
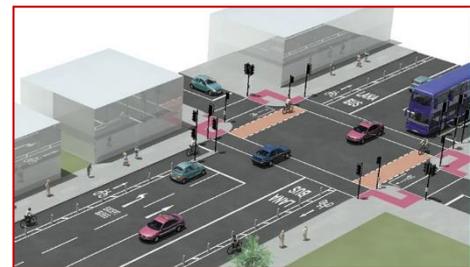
The alternative arrangement consists of left-turning drivers turning across the cycle lane from the bus lane. This proposed layout presents a particular risk to cyclists wishing to proceed straight-ahead or turn right at the junction.

The lack of consistency in the junction layouts along the bus corridor route could lead to inappropriate, or unsafe, manoeuvres by left-turning drivers, in particular those unfamiliar with the route.

Adopt and implement a consistent layout at the junctions along the route. Should the chosen layout consist of left-turning vehicles crossing the straight-ahead cycle lane then measures will be required to ensure that cyclists are not put at risk of being struck by turning vehicles. Some guidance is available in Section 4.5 of the National Cycle Manual.

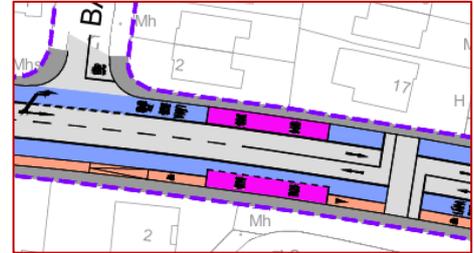
Summary: Proposed location of bus stop may impede visibility for drivers exiting from nearby side road and/or impede visibility for drivers approaching the signalised pedestrian crossing immediately downstream.

A bus stop is proposed on the northern side of the Ballyowen Road, east of Ballyowen Drive. There is a risk that stationary buses at this bus stop could impede visibility to the left for drivers exiting from Ballyowen Drive, resulting in unsafe exiting manoeuvres and side-on collisions.

In addition, stationary buses at this bus stop may impede visibility of eastbound drivers in the adjacent traffic lane towards the signals at the pedestrian crossing immediately downstream, resulting in approaching drivers being unaware of the need to stop, leading to a failure to stop and overshoot into the crossing resulting in possible vehicular/pedestrian collisions.

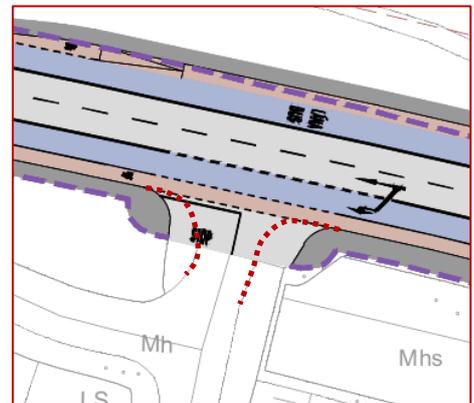
The proposed layout of the junction of Larkfield Avenue with the Ballyowen Road will result in pedestrians travelling east/west along the Ballyowen Road undertaking a lengthy carriageway crossing at the junction mouth increasing their exposure to vehicles, and consequently increase the risk of vehicular/pedestrian collisions.

In addition, the proposed layout does not tie in with the existing footpaths on Larkfield Avenue, which will require pedestrians to enter the carriageway as they travel to/from Larkfield Avenue and the Ballyowen Road.

Amend the proposed road layout to reduce the width of the junction mouth and to provide connectivity between the footpath on Larkfield Avenue and the proposed footpath on the Ballyowen Road.

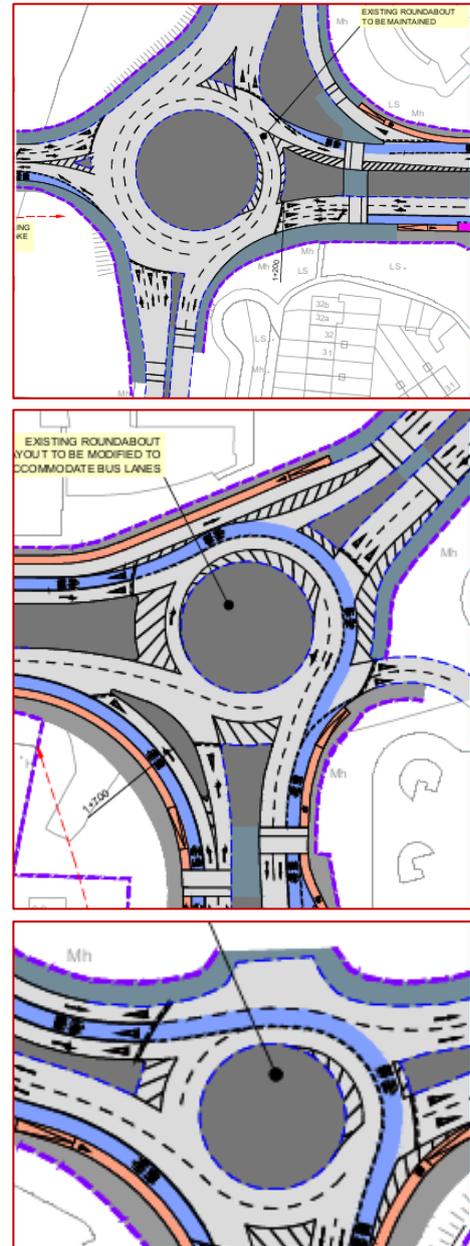
The proposed location of pedestrian or toucan signalised crossings immediately downstream from the roundabout exits could result in drivers, particularly those on dedicated left-turn lanes at the roundabouts, being insufficiently aware of the upcoming crossing as their attention would have been focused on other traffic as they exit the roundabout, leading to a failure to stop, overshoot incidents and possible collisions with crossing pedestrians.

In addition, the retention of these roundabout junctions is inconsistent with the proposed treatment elsewhere along the route, both to the west and east, where existing roundabouts are proposed to be replaced by signalised junctions.

Provide signalised junctions at these locations.

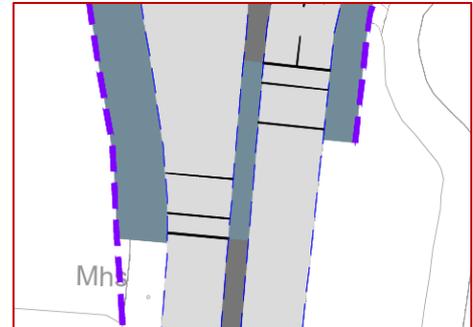
It is unclear if the refuge island within this crossing is of adequate width to cater for the likely volumes of pedestrians and to/or cyclists likely to use this crossing, in particular when items of roadside furniture had been placed within the island.

Insufficient width of refuge can increase the likelihood of pedestrians or cyclists within the refuge being struck by part of a passing vehicle.

Ensure that adequate width is provided within refuges proposed as part of the project.

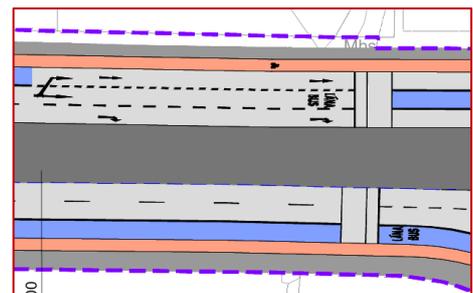
A weaving length has been indicated on the eastbound approach to the signalised pedestrian crossing, where buses must move right in order to turn right at the roundabout further downstream, and where traffic wishing to proceed straight-ahead at the roundabout must move left.

The length of this weaving section is relatively short, and it is located on the immediate approach to a pedestrian crossing.

Drivers undertaking weaving manoeuvres may be insufficiently aware of the status of the signals at the pedestrian crossing, resulting in a failure to stop leading to overshoot incidents and collisions with crossing pedestrians.

In addition, many drivers may not be aware of the need to move left in order to proceed straight-ahead at the upcoming roundabout junction, resulting in late lane-change manoeuvres on the immediate approach to the signalised pedestrian crossing and possible side-swipe collisions.

Recommendation

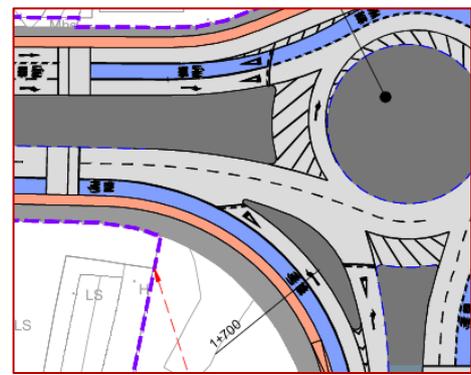
A signalised pedestrian crossing has been indicated immediately downstream of a dedicated left-turn lane at the roundabout.

Drivers exiting from the left-turning lane will have their focus primarily to the right, towards other vehicles exiting from the nearby roundabout, and may be insufficiently aware of the status of the signals at the pedestrian crossing resulting in a failure to stop and overshoot into the crossing, leading to vehicular/pedestrian collisions.

Either relocate the signalised pedestrian crossing so that there is a greater distance between the left-turning lane and the crossing to allow drivers sufficient distance/time to be sufficiently aware of the crossing, or replace the proposed roundabout junction with a signalised junction with the pedestrian crossings incorporated into it.

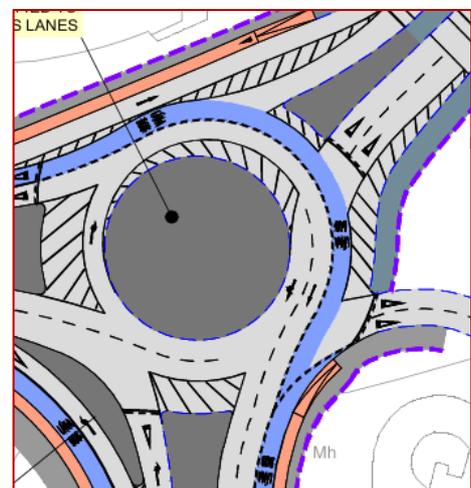
Summary: Hatched roadmarkings at roundabout junction will fade over time rendering the layout indistinct leading to unsafe manoeuvres and collisions.

A significant amount of hatched roadmarkings are proposed at the roundabout junction to guide drivers.

These hatched markings will fade/wear-off over time, and the layout may become indistinct and insufficiently clear, resulting in unsafe manoeuvres and side-swipe collisions.

Amend the proposed junction layout to replace at roadmarkings with kerbed build-outs/islands.

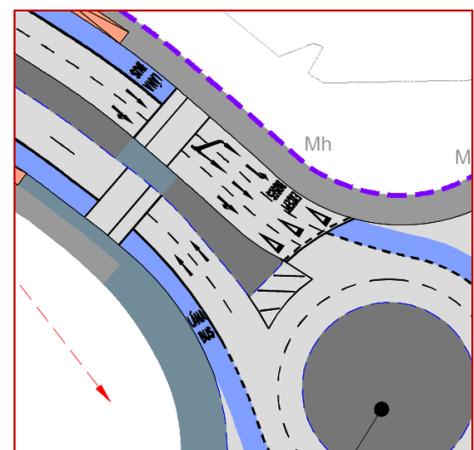
Location: Drawing Sheets 5 & 6

Summary: Queues forming at signalised crossings located immediately downstream of roundabout exits may extend upstream into the roundabout circulating carriageway creating congestion, leading to driver frustration and resulting in rash manoeuvres.

Signalised pedestrian crossings have been indicated immediately downstream of a number of roundabouts within the Liffey Valley area.

The proximity of these signalised crossings to the roundabouts could result in queues at the signalised crossings extending back into the upstream circulating carriageway, leading to congestion and obstructions to drivers attempting to enter the roundabout from the other arms. This could lead to driver frustration and rash/unsafe manoeuvres.

If the signalised pedestrian crossings were located to points further downstream of the roundabout exits, this could address this issue, but the crossings may then no longer be on the likely pedestrian desire line resulting in unsafe pedestrian crossing.

Therefore, it is recommended that the roundabouts be replaced by signalised junctions with pedestrian crossings incorporated within them.

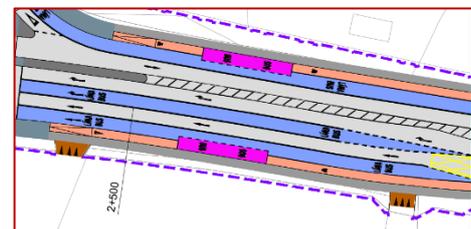
Location: Drawing Sheet 8 – Coldcut Road

The proposed road layout on Coldcut Road is relatively complex, and includes the development of a number of lanes over short distance west of the M50 Overbridge on the approach to the signalised junction with Liffey Valley.

The number of different lanes developed over this short section is likely to lead to driver confusion and late lane-change manoeuvres resulting in possible side-swipe collisions.

Rationalise the number of lanes being developed over this short section of road to minimise driver confusion and promote compliance with the road layout.

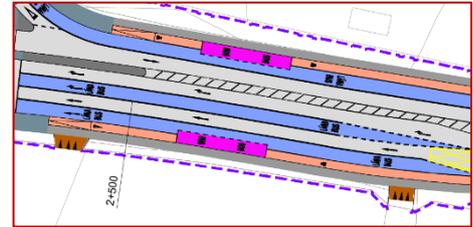
Summary: Unsafe manoeuvres arising from driver frustration showed queuing vehicles from signalised junction block straight-ahead traffic.

The proposed road layout on Coldcut Road is relatively complex, and includes the development of a number of lanes over short distance west of the M50 Overbridge on the approach to the signalised junction with Liffey Valley.

Queuing vehicles at the signalised junction may extend back to the overbridge and block access to the straight-ahead lanes, which could give rise to straight-ahead drivers entering the adjacent cycle track or placing two wheels on the kerb in order to pass queuing vehicles in order to enter the straight-ahead lanes.

These manoeuvres could result in collisions with vulnerable road users on the adjacent footpath, shared-use path or cycle track.

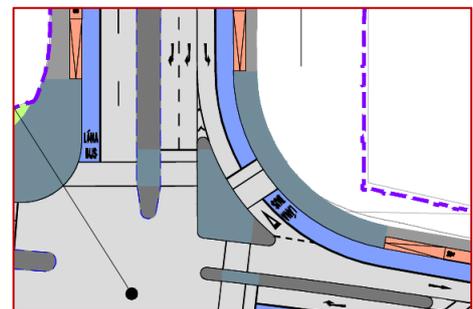
Two lanes are indicated turning left from Liffey Valley onto the Coldcut Road eastbound. It is unclear if any lane widening has been provided within these two left turning lanes.

Should no lane widening be provided there is a risk that the lanes will be insufficient to accommodate the swept path of large vehicles/buses, resulting in encroachment into the adjacent lane and possible side-swipe collisions with vehicles in the adjacent lane.

During the design development undertake a swept-path analysis of the turning movements at this junction and ensure that adequate lane widths are provided to accommodate the swept path of large vehicles/buses turning left.

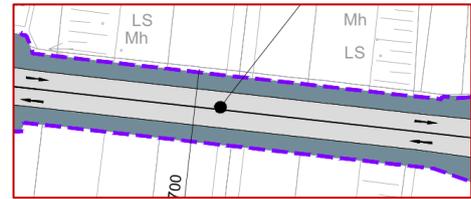
Summary: Unclear if existing bridge parapets are adequate to restrain an errant bus or cyclist.

It is unclear if the existing parapets on the Coldcut Road overbridge, which crosses over the M50, are adequate for the amended road layout/use, for example capable of restraining an errant bus or of a height to restrain an errant cyclist.

These should be reviewed during the design development and if necessary replaced with appropriate parapets.

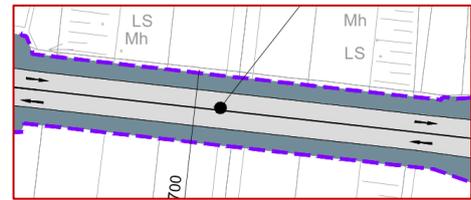
Summary: Unclear if sufficient width is available on the existing Coldcut Road overbridge for the proposed shared-use paths.

It is unclear if the existing Coldcut Road overbridge is of adequate width to accommodate the proposed road layout, in particular the shared-use paths on either side of the bridge, once the existing/future road side furniture (e.g. public lighting columns) is taken into account.

Ensure that adequate effective width of shared-use paths is provided.

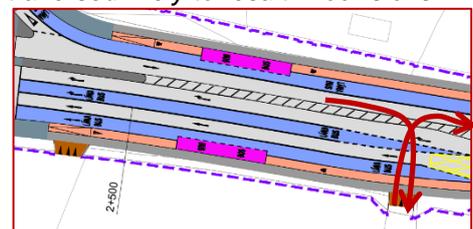
Summary: Right-turning manoeuvres requiring multiple lanes to be traversed likely to result in collisions.

Two private accesses have been indicated on the southern side of the Coldcut Road where a relatively complex road layout is proposed. Vehicles attempting to turn right into, or right out of, these accesses will have to cross a cycle lane, two bus lanes & two traffic lanes.

These manoeuvres would be difficult to complete due to the number of different traffic streams a right-turning driver would have to be aware of, and take account of, in order to complete this manoeuvre safely.

It is considered likely that right-turns into, or out of, these accesses would result in side-on collisions.

Replace the proposed hatching between opposing traffic directions on this section of Coldcut Road with a solid island, and limit access/egress to/from these private accesses to left-in or left-out only.

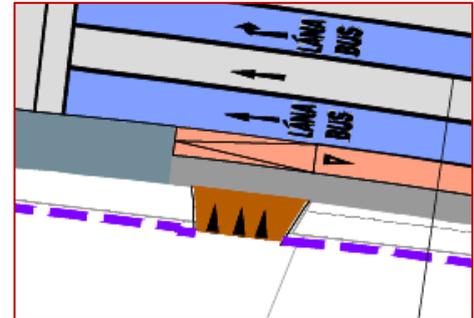
Summary: Private access indicated at same location as transition from on-road cycle lane to off-road shared-use path.

A private access has been indicated at the same location where a proposed cycle facility transitions from an on-road cycle lane to an off-road shared-use facility, immediately east of the Liffey Valley/Coldcut Road junction. This will result in vehicles entering/exiting from this private access traversing a section of carriageway with varying height kerbs.

Either relocate the proposed access or relocate the cycle lane transition.

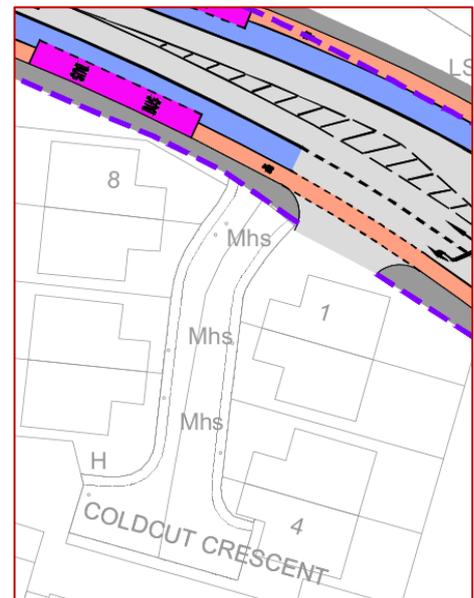
Summary: Stationary buses at proposed bus-stop may block visibility for exiting side road drivers resulting in unsafe exiting manoeuvres and side-on collisions stop

The access to Coldcut Crescent is shown incorrectly on the drawings provided. When this junction location is corrected, presumably during subsequent design development phases, the location of the proposed bus stop could result in stationary buses at the bus stop blocking visibility for drivers exiting from Coldcut Crescent and wishing to turn right onto Coldcut Road, leading to unsafe exit manoeuvres and possible side-on collisions.

Ensure that adequate visibility is available for exiting side road drivers from Coldcut Crescent, and that it is not obstructed by stationary buses at the proposed bus-stop.

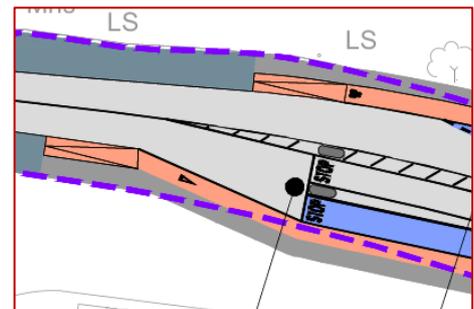
Summary: Buses encroaching into cycle lane will present hazards to cyclists.

A transition from an on-road cycle lane to an off-road shared-use path is shown immediately downstream (west) of the bus gate on Coldcut Road.

There is a risk that buses proceeding west from the bus gate may cut across the corner at this transition, encroaching into the cycle facility and presenting a hazard to cyclists.

Amend the proposed road layout to bring cyclists off the carriageway upstream of the bus gate. Undertake a swept-path analysis to ensure that the proposed road layout can accommodate westbound buses at this location without encroachment into either the cycle facility or the opposing traffic lane.

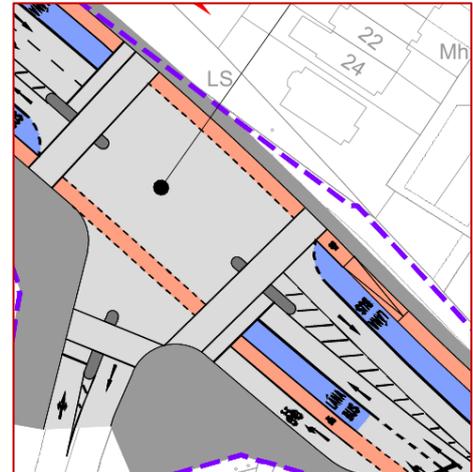
The splitter island at this location would appear to be insufficient to act as a pedestrian refuge, with a resulting risk of pedestrians within the island at risk of being struck by passing vehicles.

Pedestrians could become stranded mid-crossing may attempt to complete the crossing outside of the dedicated pedestrian phase, with a resulting risk of being struck by a vehicle or cyclist.

Provide a two-stage pedestrian crossing with a pedestrian refuge of adequate width/size and a push button located within the pedestrian refuge to enable pedestrians to call a subsequent crossing phase.

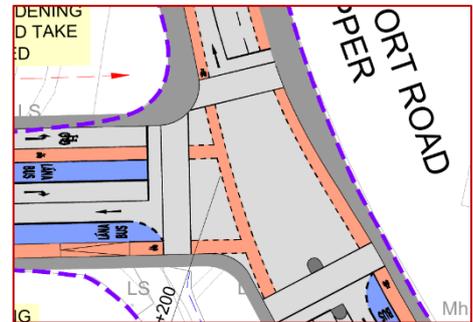
Two right-turning lanes are indicated from Coldcut Road onto Ballyfermot Road. It is unclear if the proposed junction layout can accommodate the swept-path of two turning traffic lanes at this location. If insufficient space exists within the junction layout to accommodate two traffic streams turning simultaneously this could lead to side swipe collisions.

An absence of guidance markings for these right-turning lanes could result in some drivers drifting into the adjacent lane leading to side by side collisions.

Undertake a swept-path analysis to ensure that adequate space is available to accommodate two-turning traffic streams at this location. Include guidance markings to assist right-turning drivers from Coldcut Road.

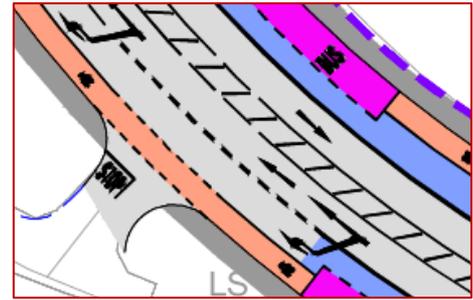
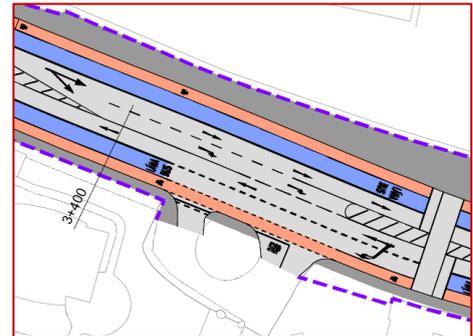
Summary: Right-turning manoeuvres from priority junctions where drivers are required to cross multiple bus, traffic & cycle lanes could result in unsafe exiting manoeuvres and side-on collisions.

Drivers exiting from these side roads wishing to turn right will have to cross multiple lanes, including cycle lanes. It will be difficult for right-turning drivers to identify safe gaps in the approaching traffic in order to complete a right-turning manoeuvre, possibly leading to unsafe manoeuvres and side-on collisions.

In addition, exiting drivers from the hospital entrance wish to turn right may be insufficiently aware of the status of the signals at the signalised pedestrian crossing immediately downstream of the entrance, resulting in overshoot into the crossing and possible collisions with pedestrians.

Amend the permitted manoeuvres at the service road junction to be left-in/left-out only.

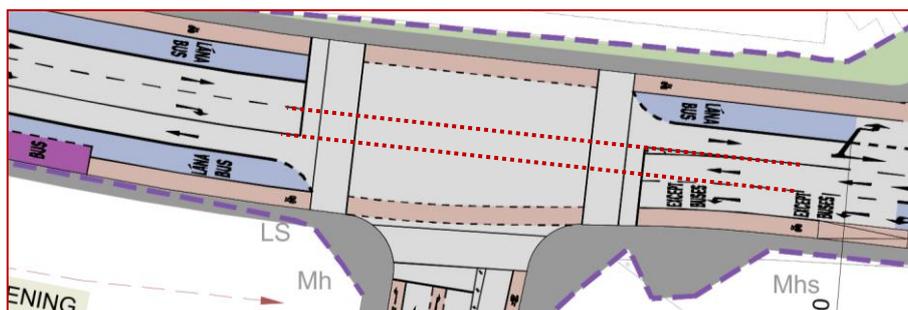
Location: Drawing Sheet 11 -

The straight-ahead lane on Ballyfermot Road westbound at the junction with the entrance to Cherry Orchard Hospital is in line with the eastbound right-turning lane. This could result in westbound drivers inadvertently entering the opposing right-turn lane leading to late correction manoeuvres and side-swipe collisions, or to log-speed head-on collisions with oncoming vehicles.

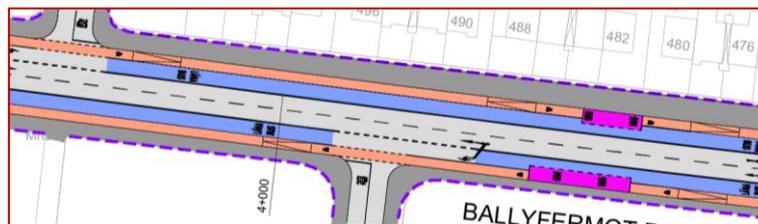
Location: Drawing Sheet 12

Summary: Absence of controlled pedestrian crossing at location where likely pedestrian desire line across Ballyfermot Road will exist could lead to uncontrolled crossings and vehicular/pedestrian collisions.

No pedestrian crossing has been indicated in the vicinity of the Ballyfermot Road/Blackditch Road junction. There is a likely pedestrian desire line to cross Ballyfermot Road at this location, given the proximity of the side roads to the north and south of Ballyfermot Road and the proposed bus stops nearby.

The absence of a signalised pedestrian crossing could result in uncontrolled pedestrian crossing manoeuvres, with pedestrian crossing two traffic lanes, two bus lanes and two cycle lanes, with a resulting increased risk of vehicular/pedestrian collisions.

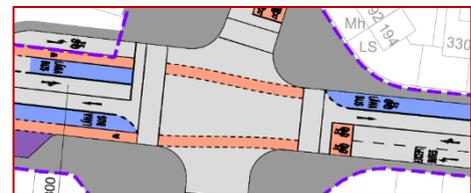
Recommendation

During the design development ensure that the signal phasing at this junction permits right-turning vehicles to proceed unopposed.

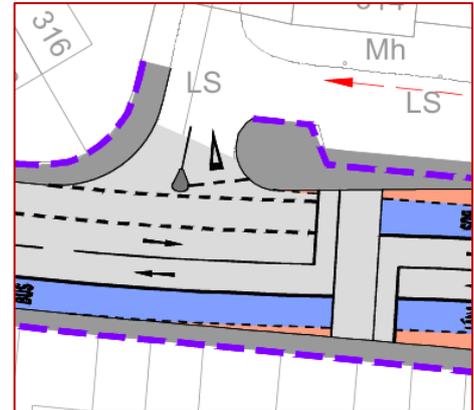
3.2.32 Problem

Location: Drawing Sheet 14 – Colepark Road

Summary: Proximity of signalised pedestrian crossing to priority junction may result in left-turning side road drivers being insufficiently aware of the status of the signals resulting in overshoot into the crossing and vehicular/pedestrian collisions.

The proximity of the signalised pedestrian crossing to the east of the priority junction between Colepark Road and Ballyfermot Road may result in left-turning drivers exiting Colepark Road being insufficiently aware of the status of the signals resulting in overshoot into the crossing and vehicular/pedestrian collisions.

Recommendation

Relocate the signalised pedestrian crossing away from the priority junction, or signalise this junction and incorporate the pedestrian crossing into the junction layout.

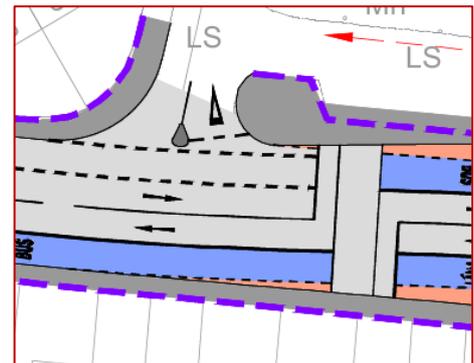
Summary: Right-turning manoeuvres from priority junction where drivers are required to cross multiple lanes could result in unsafe turning manoeuvres and side-on collisions.

It is proposed to remove the existing island at the junction of Colepark Road and Ballyfermot Road, which prohibits right-turning manoeuvres out of Colepark Road.

Drivers exiting from Colepark Road and wishing to turn right will have to cross multiple lanes. It will be difficult for right-turning drivers to identify safe gaps in the approaching traffic lanes in order to turn right, possibly leading to unsafe manoeuvres and side-on collisions.

Either amend the permitted manoeuvres at the Colepark Road junction to be left-in/left-out only, or signalise the junction and incorporate the pedestrian crossing into the junction arrangement.

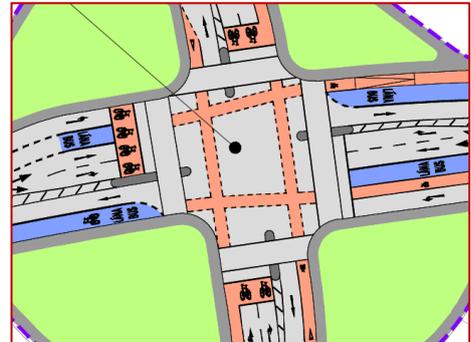
No measures have been indicated to facilitate right-turns by cyclists at the Kylemore Road junction. Advance stop lines have been indicated on three of the four arms at the junction, however these do not readily cater for right-turning cyclists who approach when the signals are green.

In the absence of measures catering for right-turning cyclists, cyclists may attempt to weave across multiple traffic lanes in order to enter the right-turning lane where they are at increased risk of being struck by a vehicle.

Provide “box-turns” to cater for right-turning cyclists at this junction.

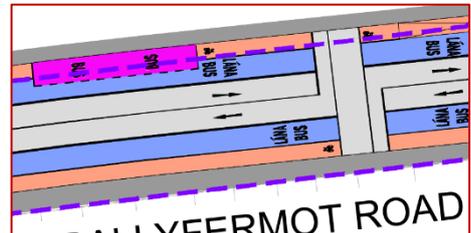
Summary: Proposed location of bus stop may impede visibility for drivers approaching the signalised pedestrian crossing immediately downstream.

A bus stop is proposed on the northern side of the Ballyfermot Road, east of the Kylemore Road junction. There is a risk that stationary buses at this bus stop could impede visibility for eastbound drivers in the adjacent traffic lane towards the signals at the pedestrian crossing immediately downstream, resulting in approaching drivers being unaware of the need to stop, leading to a failure to stop and overshoot into the crossing resulting in possible vehicular/pedestrian collisions.

Relocate the proposed bus stop or pedestrian crossing and ensure that adequate forward visibility to the signals is available for approaching drivers on all lanes.
