Appendix M1
Road Safety Audits
- Stage 1

BusConnects Dublin Core Bus Corridor Infrastructure Works – Package B

Road Safety Audit Stage 1

20/04/2022

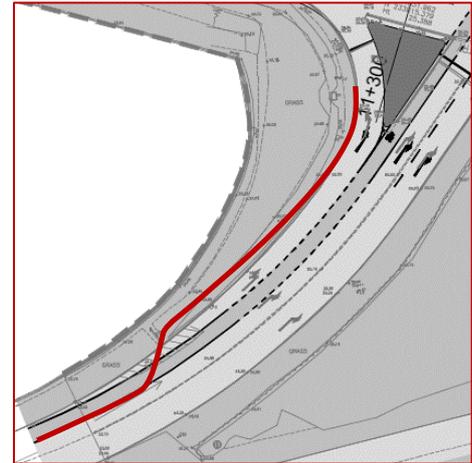
The proposed layout of the dedicated left-turning lane on Con Colbert Road on the approach to its junction with the N4 Chapelizod Bypass is such that left-turning vehicles will cross the cycle lane at a shallow angle, increasing the distance over which they will interact with the cycle lane.

Similarly, the full width of the left-turning lane does not appear to be provided until closer to the splitter island, with the result that vehicles in the left-turning lane may protrude into the adjacent cycle lane and present an obstruction to cyclists who may move into the adjacent traffic lane in order to pass with a resulting increased risk of being struck by a vehicle.

Provide a left-turning lane with a shorter, more well defined, entry taper and with a full lane width over its extents beyond the taper such that left-turning traffic will not protrude into the adjacent cycle lane.

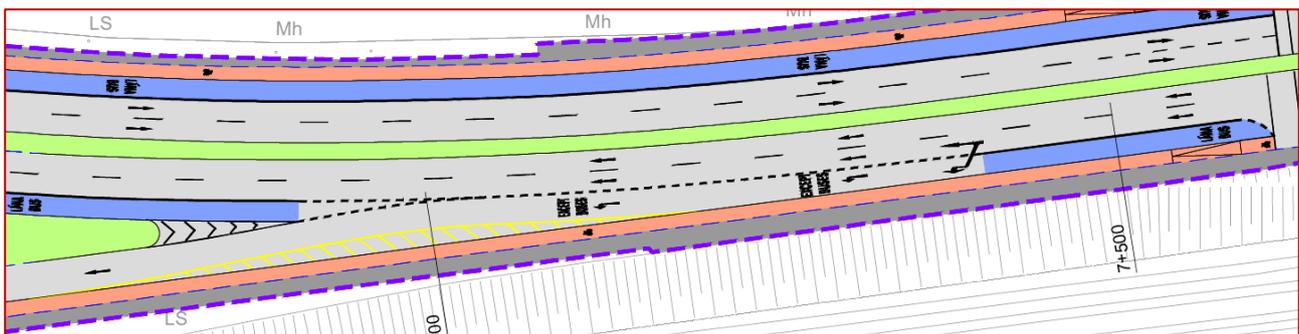
Location: Drawing Sheet 21

Summary: Increased injury severity outcomes likely should collisions occur between vehicles and cyclists due to higher speeds by left-turning/diverging westbound vehicles at junction of Con Colbert Road & Chapelizod Bypass.

The proposed arrangement for westbound diverging traffic at the Con Colbert Road junction with the Chapelizod Bypass could give rise to high speeds for exiting traffic. The provision of the proposed hatched roadmarkings adjacent to the cycle lane are unlikely to be observed by all drivers, placing cyclists in close proximity to high-speed vehicles with a resulting increased risk of serious injuries should a collision occur.

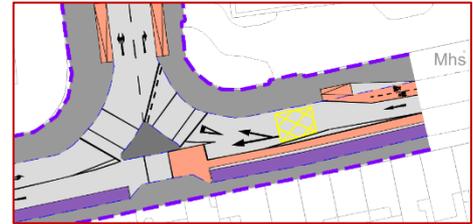
Summary: Cyclists weaving across traffic lane are an increased risk of being struck on the Inchicore Road westbound approach to the Memorial Road junction.

There is an existing two-way cycle track along the northern side of the Inchicore Road between Kilmainham and Memorial Road. It is unclear how westbound cyclists on this two-way cycle track are intended to access the westbound cycle track indicated on the southern side of Inchicore Road on its approach to the Memorial Road junction.

A failure to provide an adequate and safe means for cyclists to travel between the two cycle facilities on Inchicore Road will result in cyclists having to weave across vehicular traffic with an increased risk of being struck.

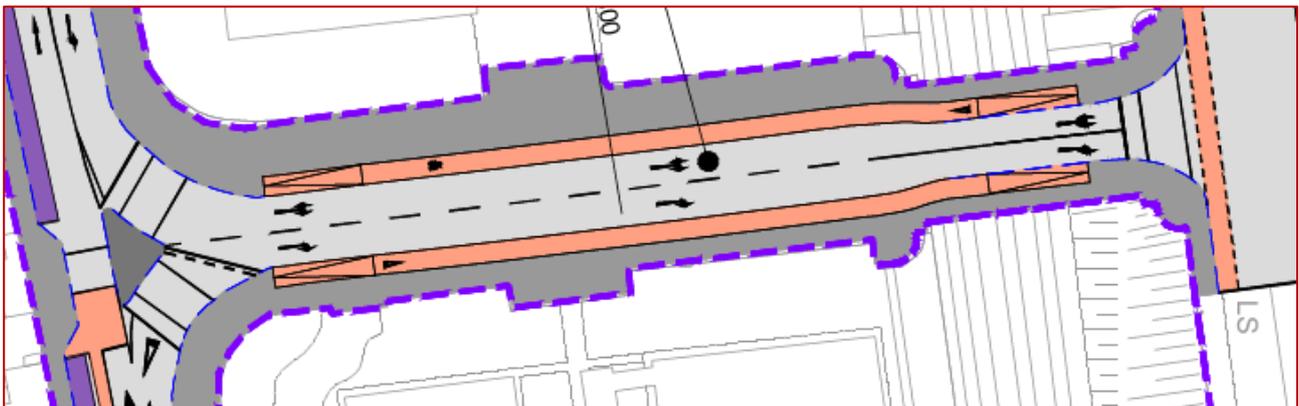
Location: Drawing Sheet 21

Summary: Proposed cycle facilities on Memorial Road do not adequately interface/integration with cycle facilities on the adjacent road network leading to unsafe manoeuvres by cyclists.

It is unclear how the proposed cycle lanes on Memorial Road interface with the cycle lanes on the adjacent road network, and in particular, how cyclists travel to/from the cycle facilities on the adjacent roads and those on Memorial Road.

Given the permitted vehicular turning movements at the northern end of Memorial Road, at its junction with Con Colbert Road, it is unclear how cyclists, in particular right-turning cyclists, can complete the manoeuvre safely. It is considered likely that cyclists will opt to remain within the traffic lane on approach to this junction, increasing the risk of vehicular/cyclist collisions.

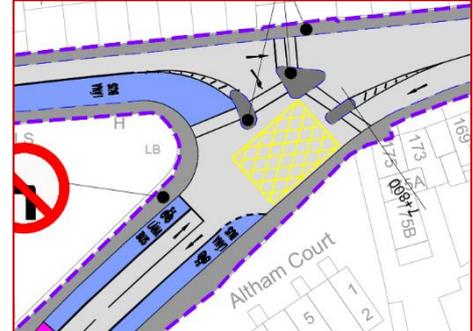
Summary: Absence of signalised pedestrian crossing of Grattan Crescent along likely pedestrian desire line may result in uncontrolled, and unsafe, pedestrian crossings.

The route for pedestrians wishing to cross Grattan Crescent immediately west of its junction with Sarsfield Road & Inchicore Road is lengthy and may not coincide with the pedestrian desire line at this location.

This could result in pedestrians undertaking uncontrolled crossings of Grattan Crescent with a resulting increased risk of vehicular/pedestrian collisions. This issue is exacerbated by the proximity of the nearby national school, with high numbers of schoolchildren expected to cross at this location.

Provide a signalised crossing of Grattan Crescent at the junction with Sarsfield Road & Inchicore Road.

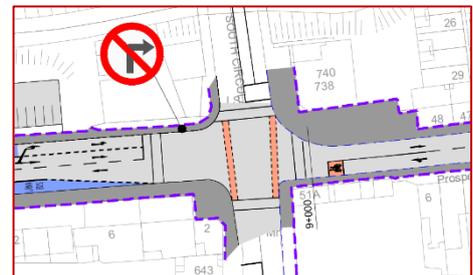
It is proposed to provide a bus gate on Old Kilmainham Road which will significantly alter the existing turning volumes at the South Circular Road junction with Emmet Road & Old Kilmainham Road.

In particular it is likely that the majority of traffic on Emmet Road will now turn left onto the South Circular Road, however the length of the left-turn lane at this location appears relatively short. This could result in significant queues forming, possibly extending into the bus lane thus negating the benefit of the bus lane provision.

Eastbound buses on Emmet Road are likely to wish to proceed straight ahead at the South Circular Road junction, onto Old Kilmainham Road. To do this they must change lane from the bus lane into the straight-ahead lane on the immediate approach to the junction, a manoeuvre that is likely to be compromised should extensive queues form within the left-turning lane on this approach.

This could result in weaving manoeuvres concentrated within a short distance on the immediate approach to the signalised junction with a resulting increased risk of side-swipe collisions.

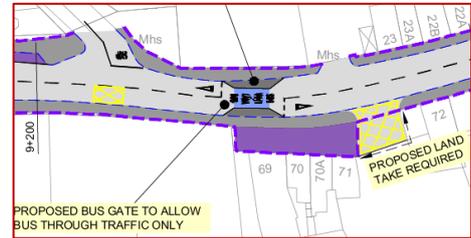
Summary: Absence of u-turn facilities at bus gate on Old Kilmainham Road could result in unsafe u-turn manoeuvres, in particular by large vehicles, with a resulting risk of collisions with other road users.

It is proposed to provide a bus gate on Old Kilmainham Road. No measures have been indicated to facilitate u-turn manoeuvres by vehicles, in particular large vehicles, who inadvertently travel along Old Kilmainham Road as far as the bus gate.

This could result in unsafe u-turn manoeuvres with resulting risks to other road users, and in particular to vulnerable road users.

Either provide facilities catering for u-turn manoeuvres at this location, or during the design development ensure that adequate signs and markings are provided advising all drivers, in particular those entering Old Kilmainham Road from side roads, that there is no through-route in the direction of the proposed bus gate.

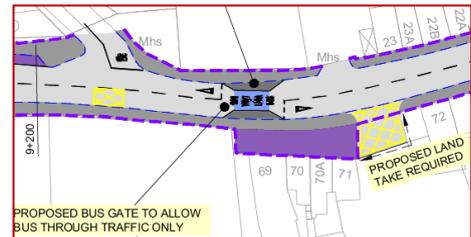
It is proposed to provide a bus gate on Old Kilmainham Road. No measures have been indicated to facilitate cyclists proceeding eastbound for westbound through the bus gate.

This could result in cyclists entering the bus gate when it is unsafe to do so resulting in them being struck by a bus travelling in either the same direction as the cyclist, or in the opposing direction.

Provide a cyclist “bypass” of the bus gate in both directions.

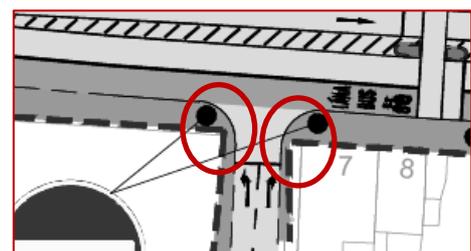
Summary: Insufficient width of footpaths could result in pedestrians stepping into the carriageway and being struck by a passing cyclist or vehicle.

The proposed footpath widths at a number of locations along Thomas Street are narrow and may not be of sufficient width to cater for the expected volumes of pedestrians at these locations. This could result in pedestrians stepping into the adjacent cycle lane/bus lane and being struck by a passing cyclist or vehicle.

Ensure that adequate width of footpath is provided at all locations along the route.

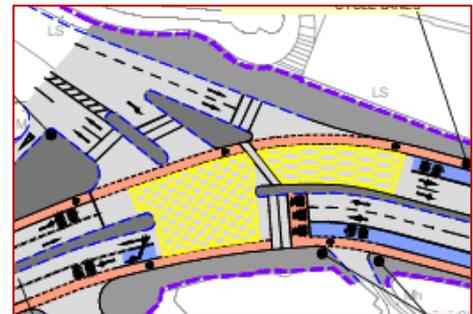
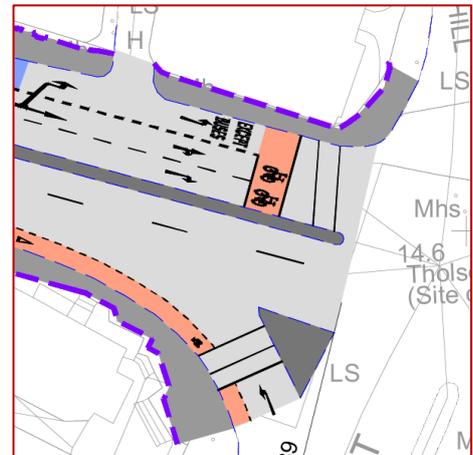
3.2.48 Problem

Location: Drawing Sheet 30 - Bridge Street/High Street Junction and High Street/Nicolas Street Junction

Amend the proposed junction layout to provide measures catering for right-turning cyclists at this junction.

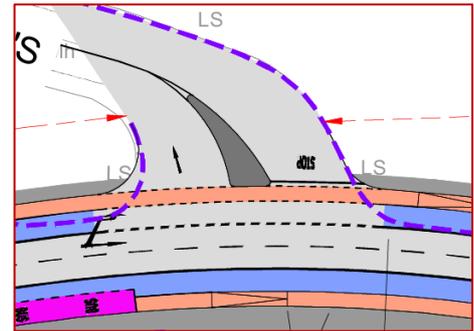
- 5.1 The proposed road layout on St Laurence's Road at its junction with Ballyfermot Road appears to be incorrect, as it does not tie in with the existing carriageway edges and does not show the existing footpaths which it is assumed are to be retained.

It has been assumed that this is a draughting error which will be corrected during subsequent design phases.
